ONAWA PUBLIC LIBRARY
Building Assessment
July 15, 2021

Onawa Public Library Building Assessment

June 24, 2021

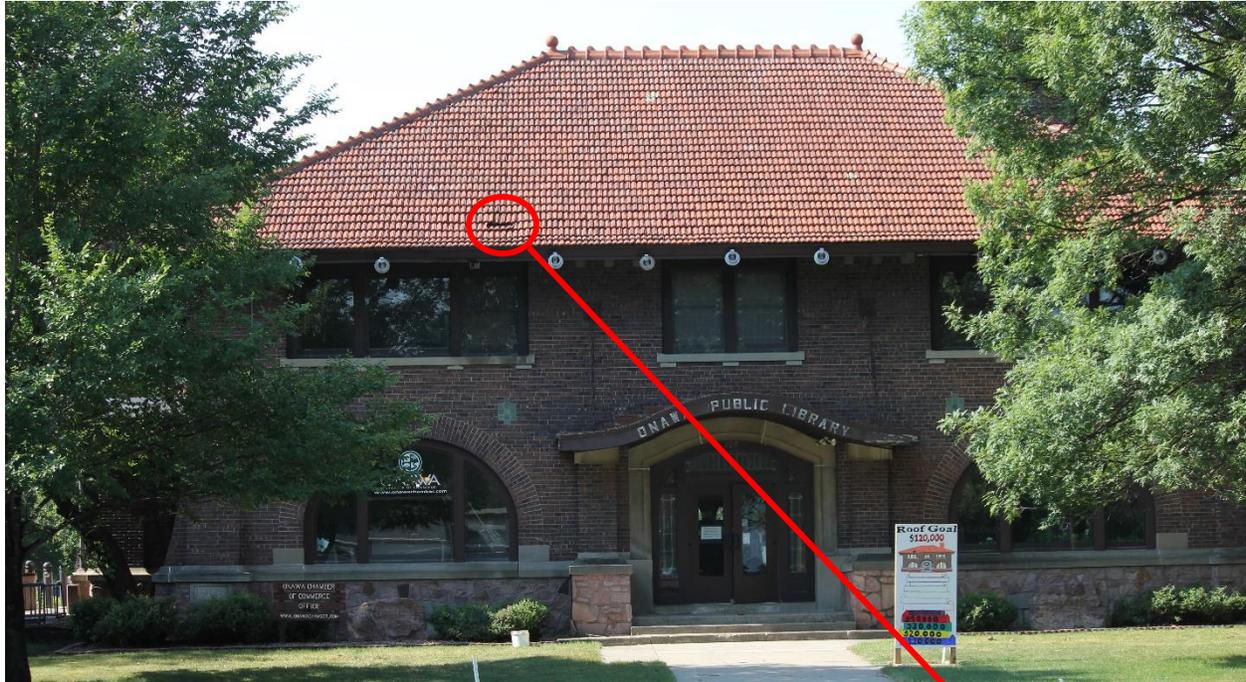
The current hole in the library roof was likely created by the impact of a tree branch during a storm. There are other locations on the north facing slope which appear to have been damaged by the impact of branches or other heavy objects. In the image below there are two shingles adjacent to one another which are out of alignment with the rest of the roof. They have shifted to the left, raising the adjacent shingle to the left and leaving a gap between the shingles to the right.

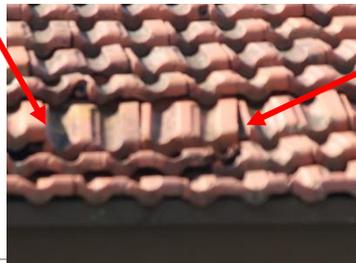
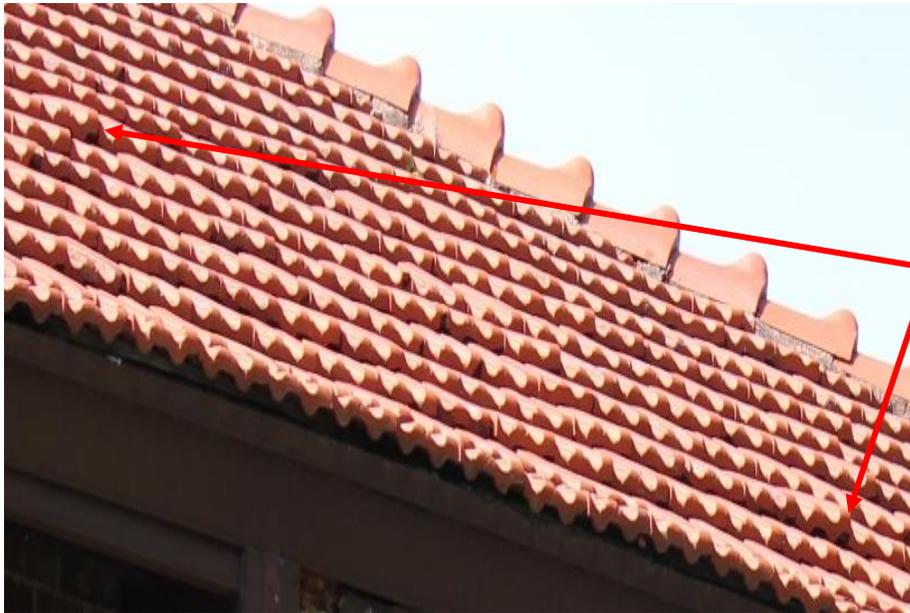
To the left is an exaggerated image showing other shingles which are no longer lying flat.

There is also a broken shingle projecting from the overhang of the roof.

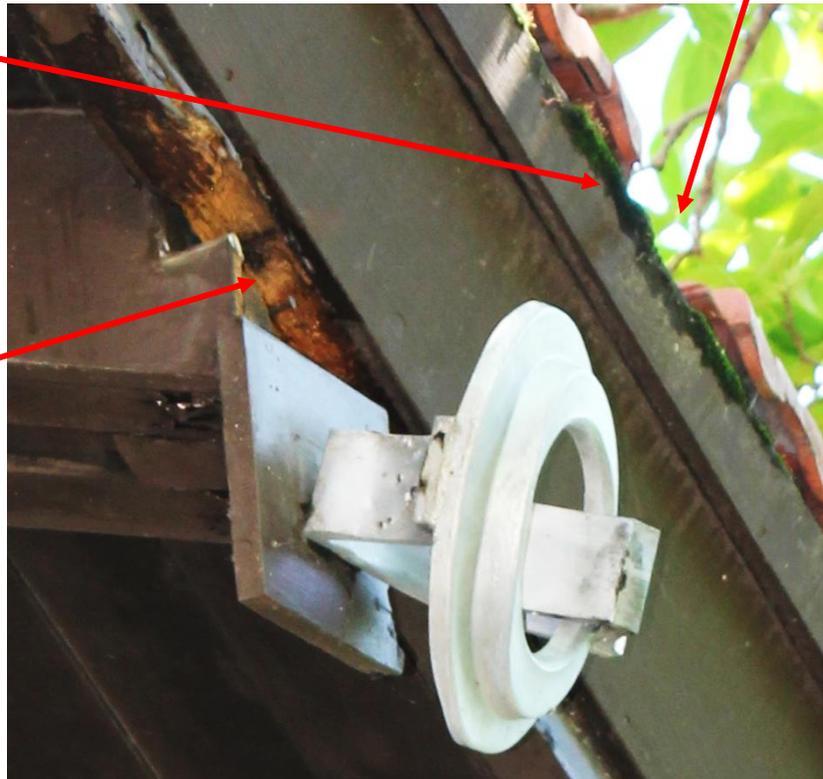
On the east side of the original building there is one first course shingle partially missing. Moss has developed in the area of the missing shingle primarily since it is on the shaded side of the roof. This location has been leaking for some time as the soffit board has deteriorated.

Water has collected at the location of the missing shingle and run into the soffit. Without a way for the water to drain, it has saturated the soffit board, causing the deterioration.

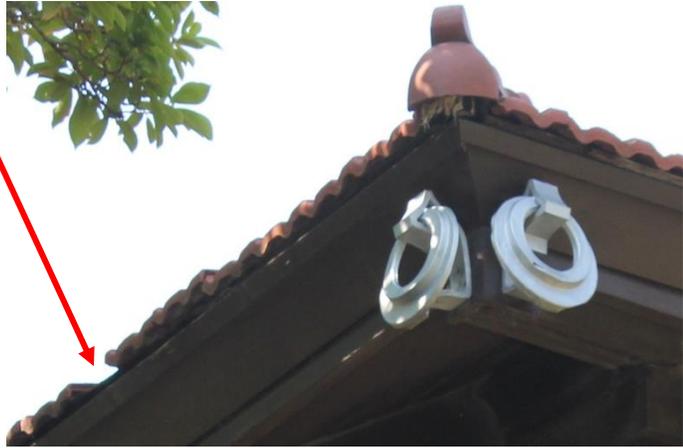
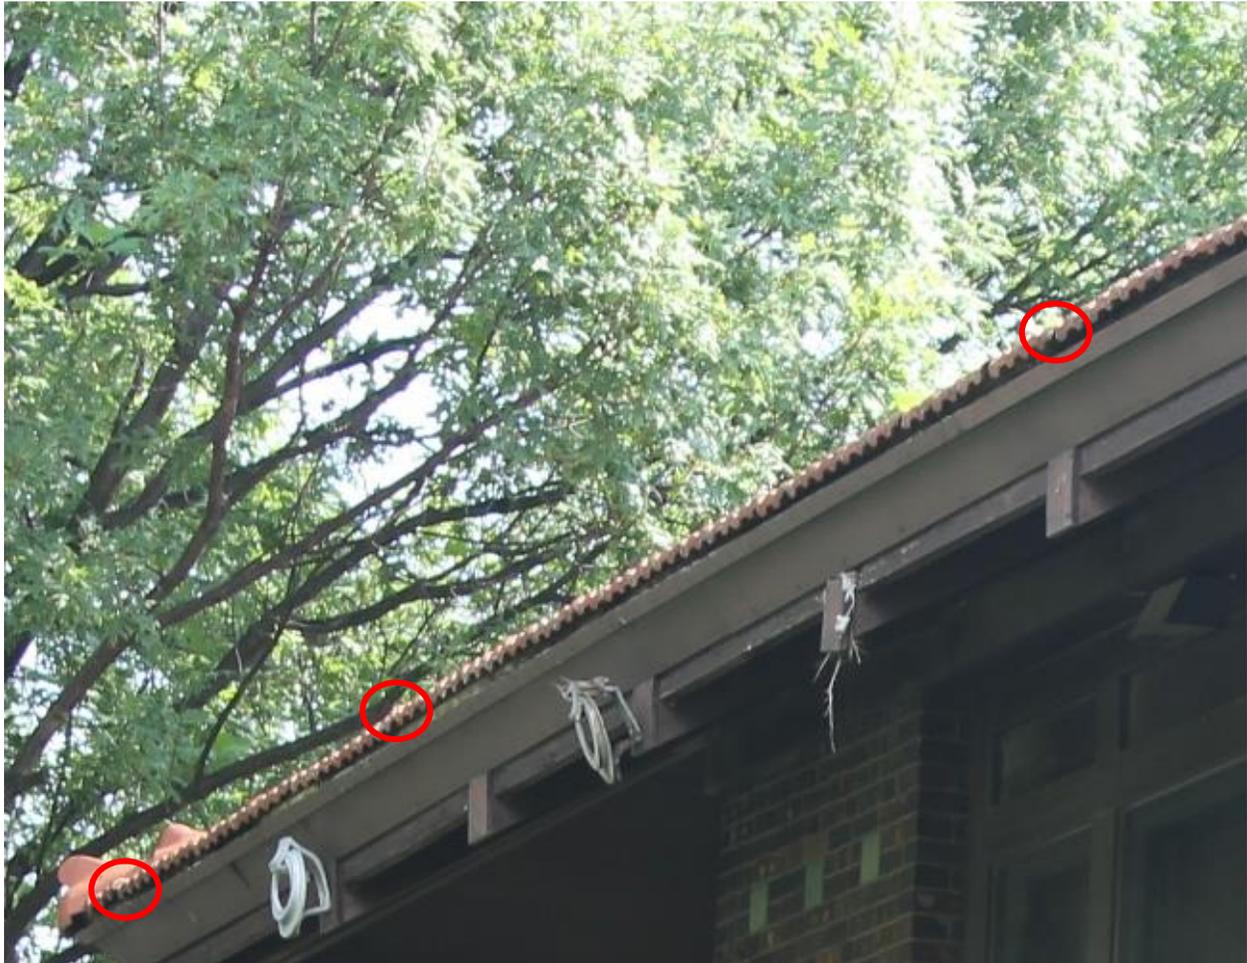
The west slope seems to have survived in better shape. I could see only a few eave shingles which are slightly misaligned.

These misalignments are minor as compared to those on the north and east.

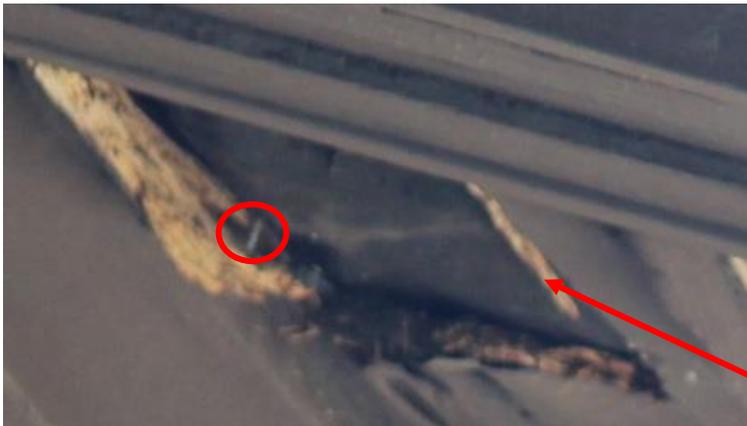
The roof leak has caused roof sheathing to deteriorate. This area under the spot where a branch or some heavy object hit the roof will require new sheathing boards.

An original roofing nail, circled in red, is also visible. To the right, from inside the library, the extensive amount of deteriorated sheathing is more readily visible.

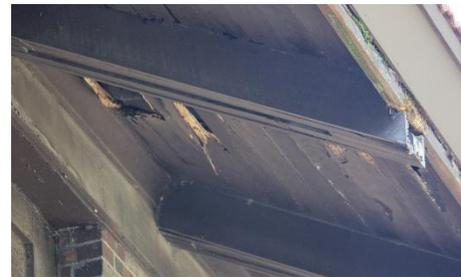
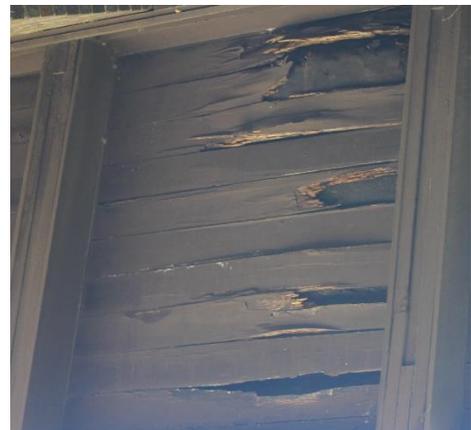
By enlarging the image, it is easy to see that a section of the sheathing is completely missing, exposing the original underlayment.

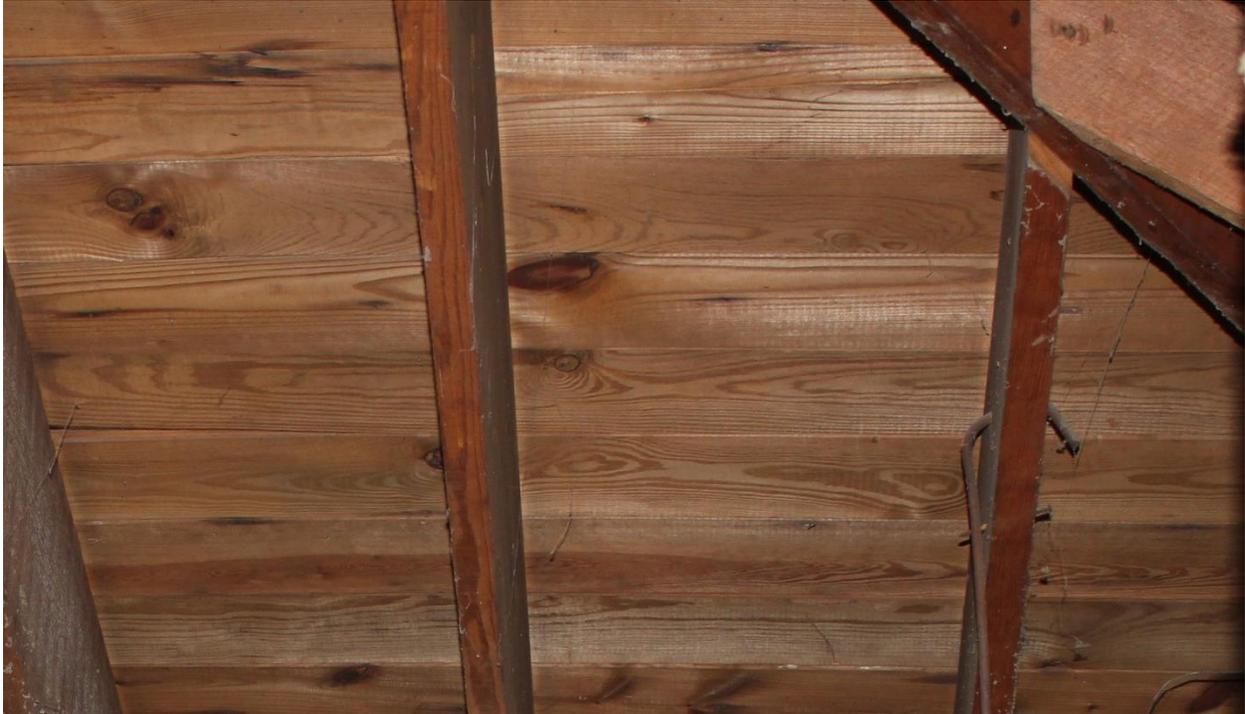
Below is a somewhat typical illustration of the sheathing boards from

inside the attic. While examination of every board was not possible, those which could be seen, and touched were all sound with no sign of moisture damage. When replacing the sheathing boards at the leak, the new lumber needs to be of the same species and dimension as the original. The original boards appear to be “ship lapped” to create a better fit. Since 1908, virtually all dimension lumber has been reduced in cross section. Replacement boards may have to be specially milled to match the original boards.

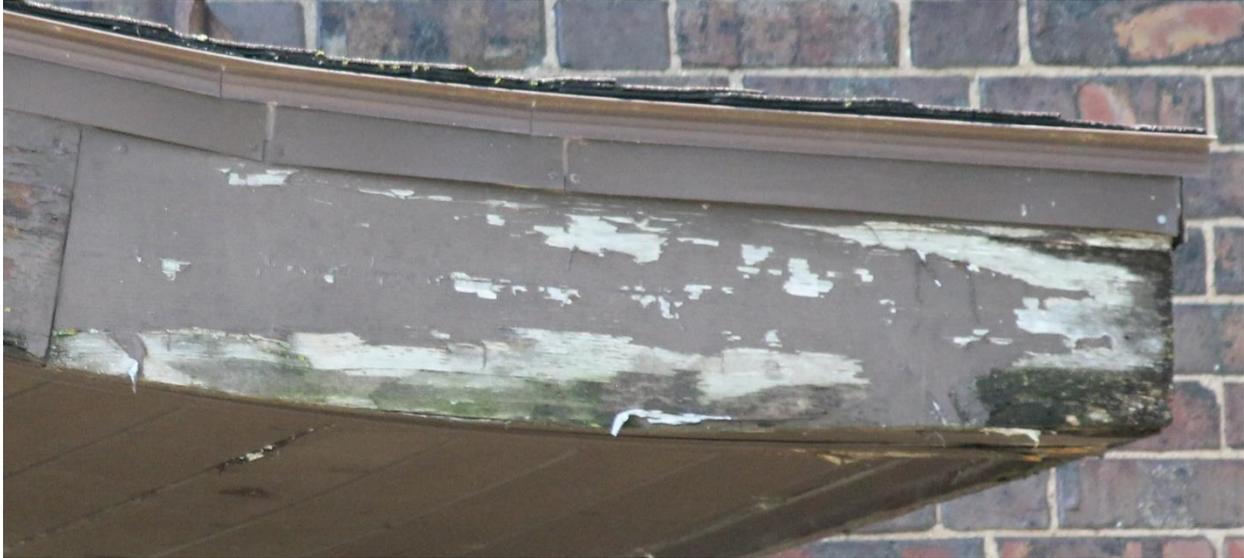
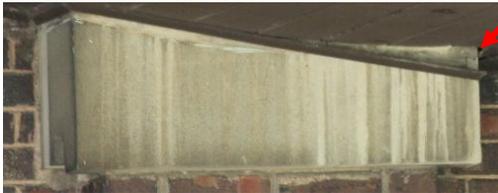
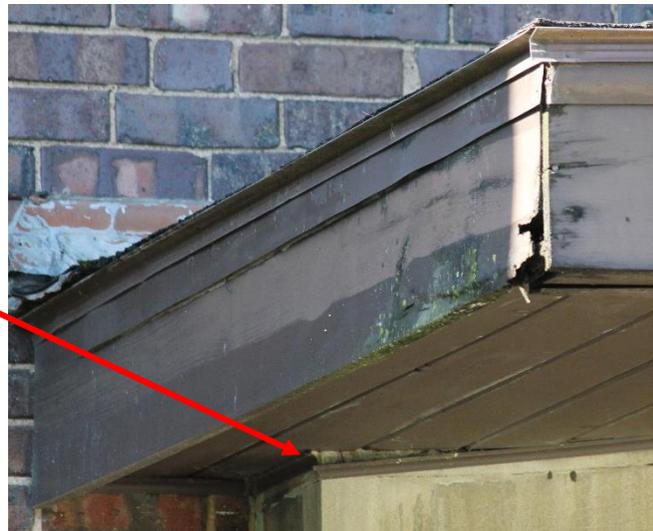
There is obvious deterioration at the eaves and on the fascia boards. There are water stains on the limestone pilaster caps beneath the canopy and the wood trim pieces at the pilasters are loose.

This damage is due to roof leaks, if not current, then at some time in the past. The image, of the canopy, to the right is from the 2nd floor window. Drainage from the roof is so slow that moss has begun to grow on the asphalt shingles. The moss further impedes the drainage process.

In addition, it is imperative to re-roof the canopy at the historic front entrance. During the process, the flashing should be redesigned to extend up the wall not less than 8 inches. The counter flashing should be redesigned to extend horizontally over the top of the lower course of counter flashing by not less than 4 inches. I highly recommend that the roof, flashing, counter flashing and trim all be copper. Copper has a life expectancy approaching 100 years or longer.

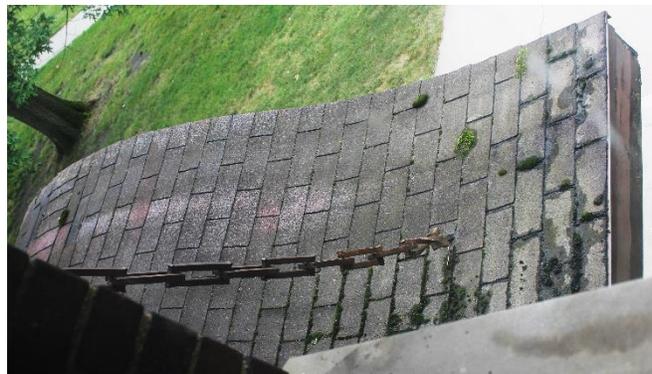
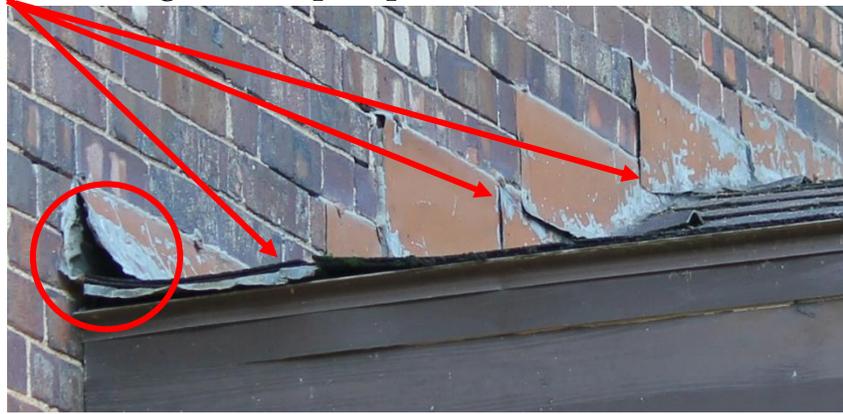
Asphalt shingles are not intended for roof slopes less than 3 inches in 12 inches. The eaves of the canopy are nearly flat, far less than the required slope for asphalt shingles. Flashing and counter flashing exists between the canopy roof and the north façade of the library. However, it appears that it was installed without enough overlap to prevent moisture from getting past it. Also, it is obvious that the asphalt shingles were not the original roof surface meaning the counter flashing has been lifted out of the way for re-roofing at least once. The action

makes it more difficult for the counter flashing to return to its original shape. The lowest piece of counter flashing in the image above, circled in red, has an extremely large opening where wind driven rain can penetrate.

In my opinion, the canopy was most likely intended to have a terne metal roof. That material was common in 1908 and could be installed with flat-lock solder joints to prevent moisture from getting to the wood roof deck. Terne metal, a composition of about 15% tin and 85% lead, is an excellent roofing material, but must be protected with paint to prevent rust. Terne metal is still available and could be reinstalled. However, copper roofing is more readily available and does not require the ongoing maintenance of repainting.

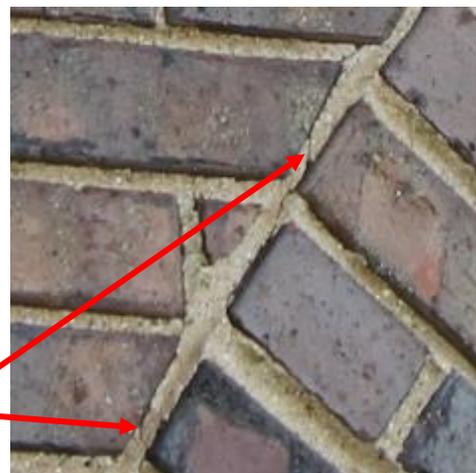
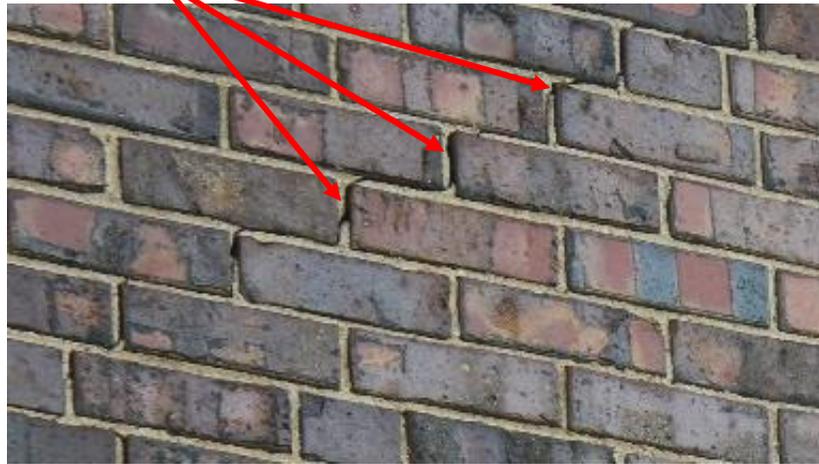
This enlargement of from the previous image near the limestone window sill, a stair-step crack has formed.

This crack and the hairline cracks described on the previous page are due to two factors, natural shrinkage of the mortar and bond failure between the mortar and the masonry units, brick or stone. The stair-step crack

occurs in an area where the brickwork is continuous across the entire length of the building. Other areas of this façade are broken up by window openings which help compensate for some of the shrinkage. Hairline cracks in particular are of virtually no concern. The stair-step crack is of little concern because it is partially due to expansion and contraction across the face of the façade. The open area of this crack is not sufficient to be of concern at this time, however. It should be monitored. Eventually, it should be repointed. If other areas require re-pointing before this crack

fully opens, then the stair-step crack should be repaired at that time. The quality of the masonry units is exceptional. I found only one fractured brick. It is located on the west side adjacent to the arch over the south window. There is no evidence that it is causing a problem. When the time comes to re-point the brick work, the masons may be able to inject a bit of epoxy into the fracture. The joints to the left and right of the brick appear to have a limited amount of mortar. Stabilizing the brick with epoxy before re-pointing is the better sequence to follow.

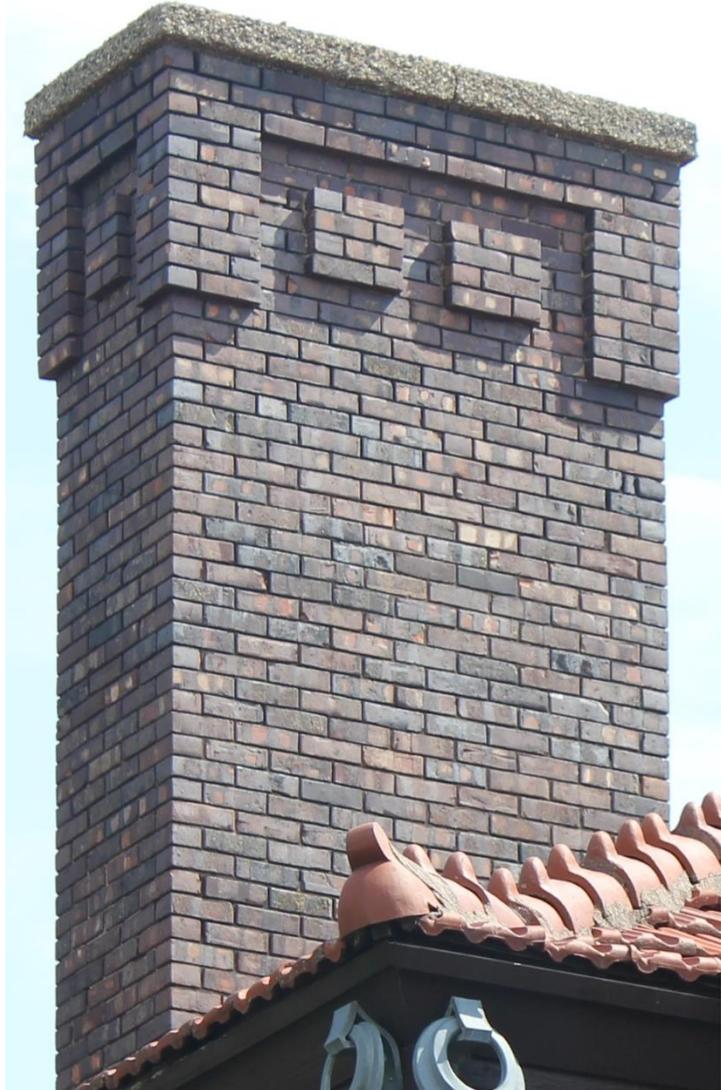
From the ground, the chimney's mortar joints appear to have weathered more than the joints on the rest of the structure. This is logical since the chimney has the worst exposure. Even so, I believe re-pointing of the chimney can wait until a craftsman is on site to repoint the other surfaces clad in brick.

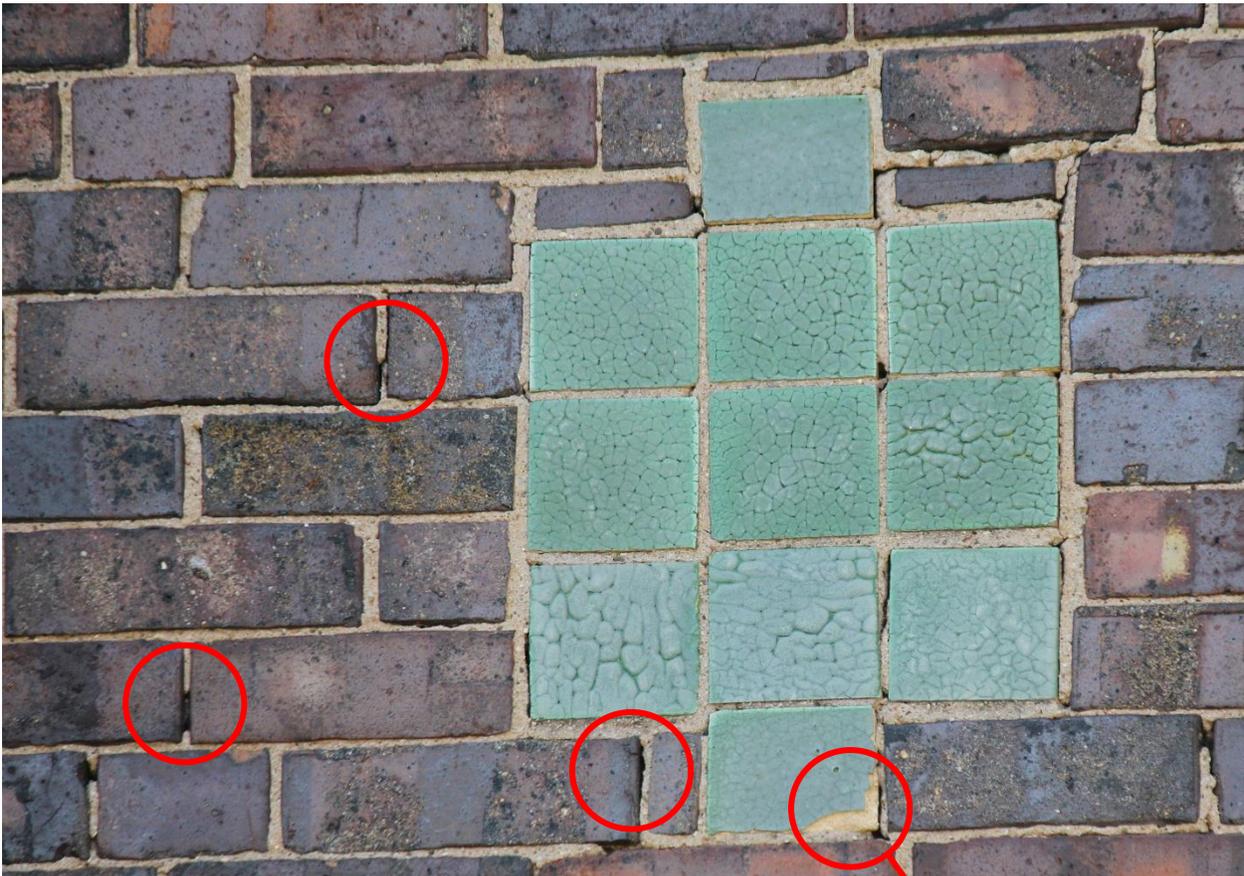
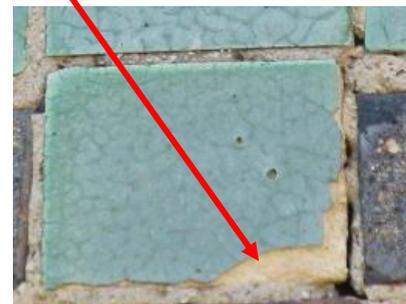
The image below is of the west façade of the library. There are a few head joints, circled in red, which are beginning to fail. Head joints more often than bed joints fail first. Before placing a brick in the wall, the mason lays down a bed of mortar on the course below. He can see the bed and knows that there is sufficient mortar. However, the end of the brick, to be laid into the wall, must be “buttered” with enough mortar to fill the head joint between the two bricks of this course. The mason cannot see the end of the

brick, consequently, less experienced masons sometimes do not provide enough mortar to completely fill the joint. The joints circled have not deteriorated enough to require re-pointing yet. They should be monitored as the openings are likely to increase in size.

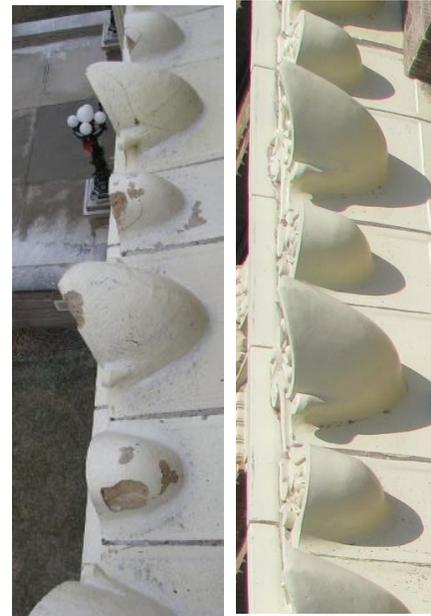
The decorative glazed tiles on the facades appear stressed from years of exposure to the weather. The “crazed” surface is typical for all of the tiles. In some locations the glaze has spalled off of the surface as can be

seen in the enlargement. Once the glaze has spalled off the underlying bisque is exposed. The bisque is less water resistant and will deteriorate over time. The tiles should eventually be re-surfaced. Edison Coating, Inc. of Plainville, Connecticut have been manufacturing masonry restoration products for more than 40 years. They offer custom colored patching products which can be used to repair the spalled areas of these tiles. Edison Coating is unique in that they only sell their products to craftsperson whom they have trained. Below is an example, before (left) and after (right), of repairs to terra cotta using Edison Coating products. The building is a courthouse in central Nebraska. The repairs were made in 2015.

Re-pointing the brick is the last priority. However, as noted, the decorative tile accents should be “re-glazed” before, or as part of the repointing project.

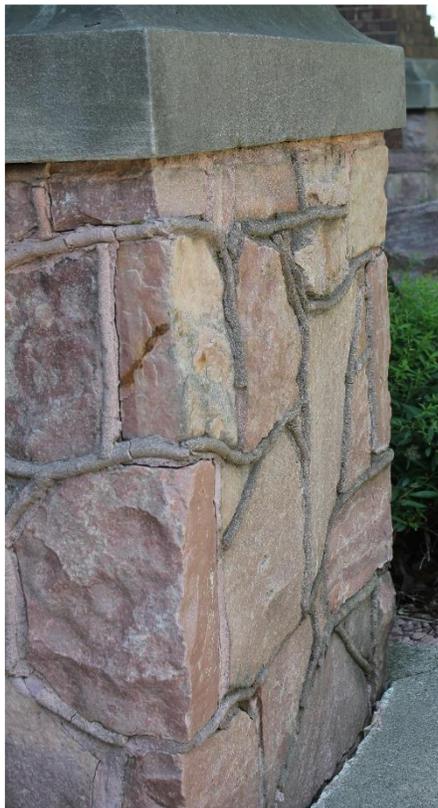
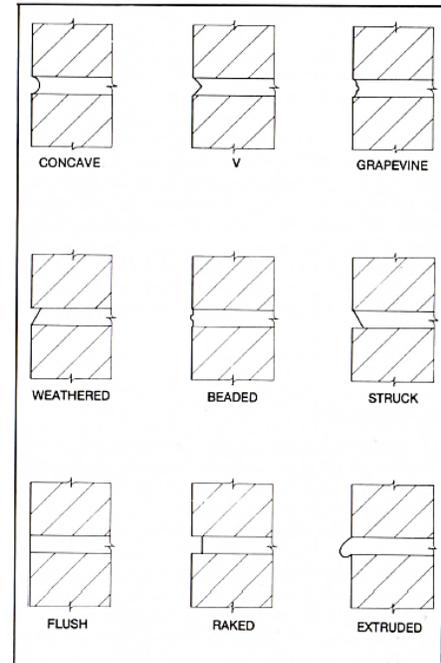
Granite is a naturally dense, hard substance with excellent weather resistance. The mortar joints in the granite water table base of the library and its addition are a problem. The style of joint is commonly called; “Extruded.”

The enlargement to the right illustrates how the mortar is tooled after it is extruded out of the joint. This style of joint is not recommended for a number of reasons including the fact that there is much more mortar exposed to the weather increasing the amount of surface which is likely to absorb moisture. It is difficult to butter the masonry units with sufficient mortar to be able to extrude enough mortar to create the tooled appearance. When the extruded mortar is not enough, the mason is left with trying to add mortar to the surface. It is obvious, from the image to the right, that the masons attempt to add mortar on the surface did not bond sufficiently and even though this is a protected location the “extruded” mortar has fallen off.

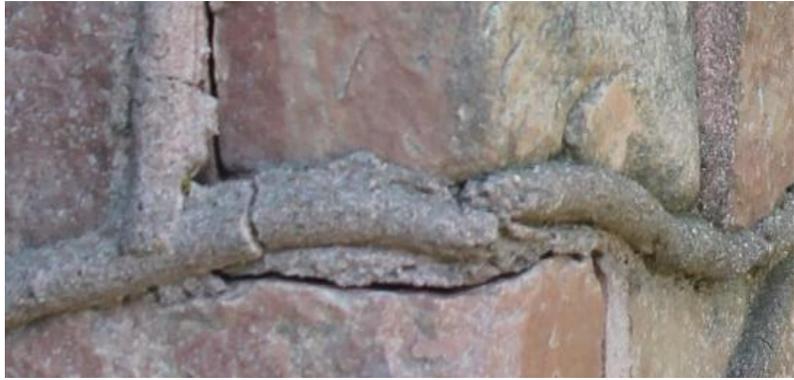
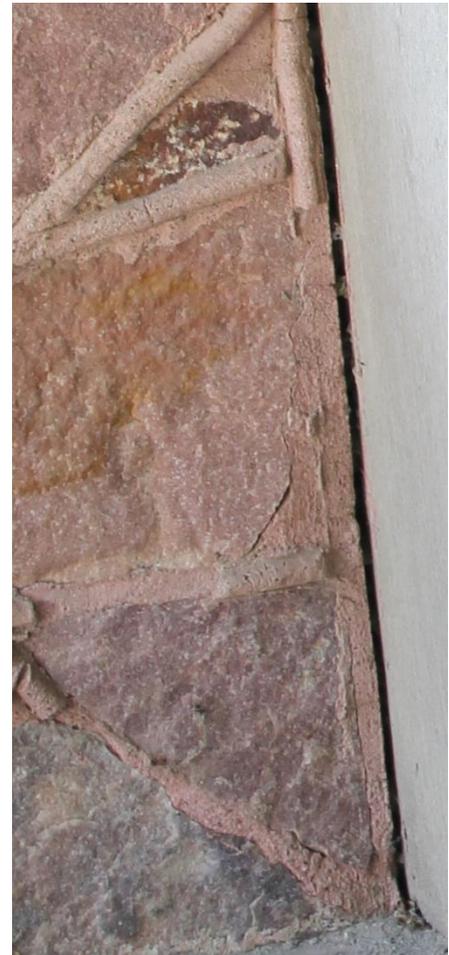
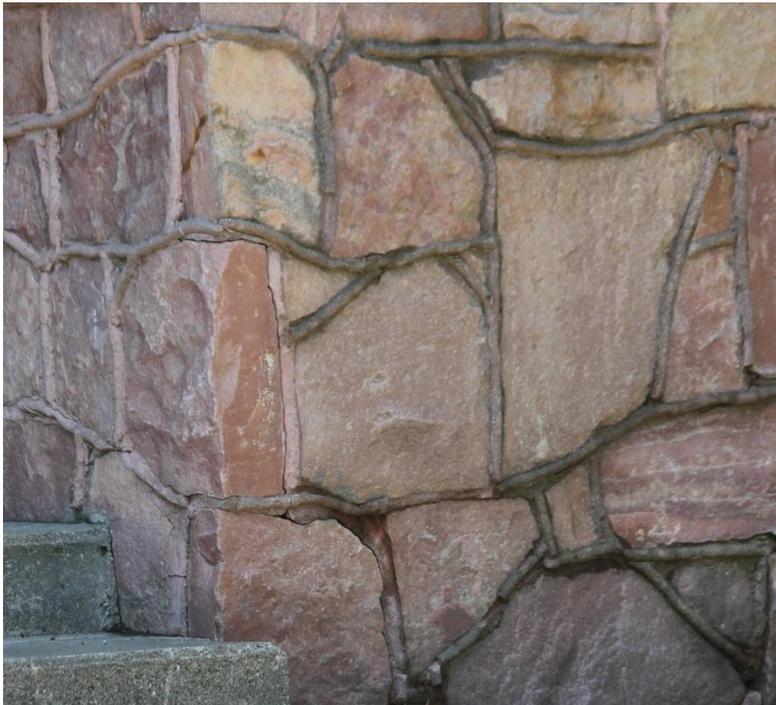
Just by noticing the various colors of mortar in this wall, it is obvious that the joints have failed and been repointed numerous times.

Unfortunately, there is no long-lasting solution for this problem. The fact that the extruded style joint is original and an obvious character-defining feature, eliminates the opportunity for the State Historic Preservation Office to consider permitting the shape to be changed to something more suitable for this exterior application. The extruded joints on the original library and its addition should be checked each spring and those that have spalled off, or failed in any other way should be re-pointed to restore the shape. The location shown to the right is at the northeast corner of the library. These open joints should be re-pointed as soon as funds are available.

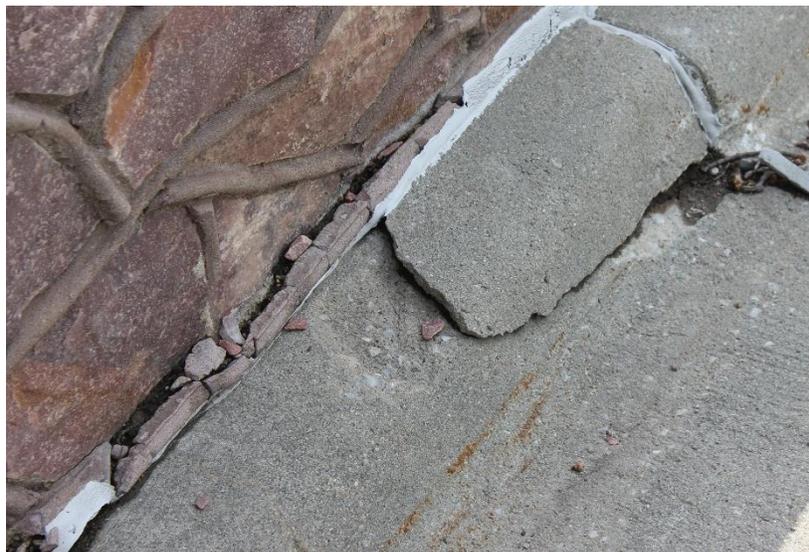
A more challenging issue exists at the granite retaining wall just east of the drop-off driveway. There is insufficient space between the poured concrete and the stone wall. The concrete is not on a frost footing thus, throughout the winter, the concrete is forced up and down from the freezing

and thawing of the soil beneath. Most frequently it is breaking the extruded mortar off the wall. Occasionally, the stone or the concrete is fractured. The wall and the driveway should be separated by

not less than a full inch. Given the shape of the granite and the mortar, there will be locations where the separation will be significantly more than an inch. Perhaps the most cost-effective solution is to cut the concrete driveway in a line about two feet from the surface of the wall. Then re-pour that portion of concrete drive and curb with sufficient space between the wall and the concrete. That joint will need to be filled with a compressible material then sealed with caulking. Before re-pouring the concrete, the wall should be examined and re-pointed where necessary.

There are numerous locations which would benefit by re-pointing in the near future. However, there is really only one issue for which I recommend immediate action: the concrete driveway adjacent to the retaining wall at the new entrance, by freeze/thaw action, damaging the wall, its mortar and the concrete drive itself. As soon as your roof repairs are complete, funds should be raised to make this correction.

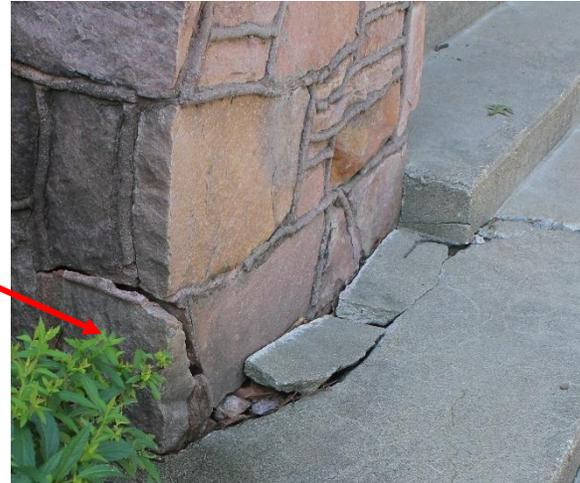
A similar condition exists at the original front door. At this location it appears that freeze/thaw action has dislodged one of the stones.

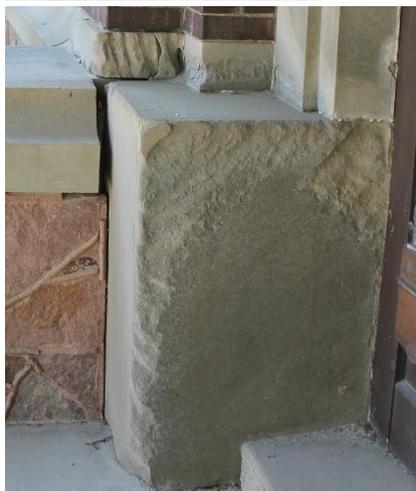
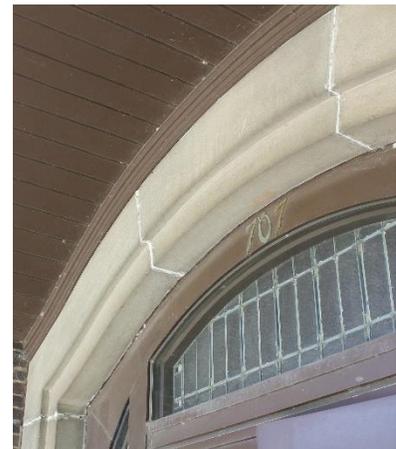
There are several different types of failure of the limestone trim. Many are of a cosmetic nature and can be repaired by a conservator with lime mortar. Others may require a Dutchman patch. The limestone in the image to the left shows streaks where water has run down the face. This is

apparently from the leaking canopy roof. Likewise, the white mortar in the joints of the arch under the canopy indicate water has washed

out the original mortar. The excess water has collected on and about the stone base, causing the stones to become soft leading to spalling in some cases. It likely has, by freeze/thaw action, pushed the cheek wall's capstone away from its original position.

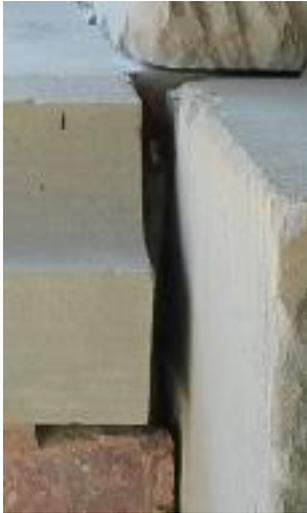
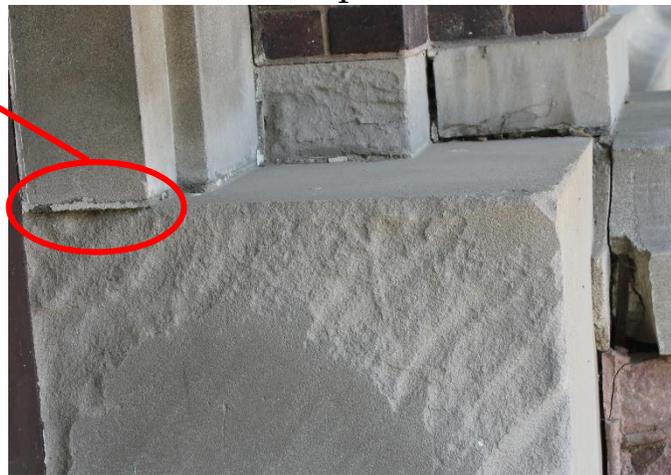
The enlargement of the joint at the capstone to the base stone shows it has moved nearly one-half inch. The capstone on the opposite cheek wall has moved a similar amount. The rough face of the limestone occurs when moisture from within the wall cannot escape through the mortar joints. The moisture then has to escape from the face of the stone. As it does, the surface of the stone becomes soft and eventually spalls, leaving the condition seen in these images. The enlarged image of the joint shows evidence of caulking having been applied to the joint, making it impossible for moisture to escape via the mortar.

Once the limestone has been preserved, the remainder of the re-pointing can be scheduled. The cheek walls at the original front entrance deserve a bit more investigation. As noted, they have moved. I believe they have stopped moving. That can be verified by installing a simple “crack monitor.” If they have not stopped moving then the repairs will require disassembly and construction of frost footing for each wall. On the other hand if, as I believe, they have stopped moving, they can be re-pointed in situ. Or, cost analysis could be done to estimate the expense of disassembly so that they could be reconstructed in their original location. To the right, the red circle illustrates the amount of mortar that was added to this joint to fill the void created by the capstone’s movement.

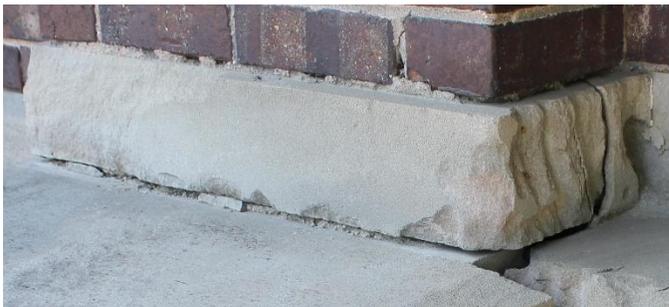
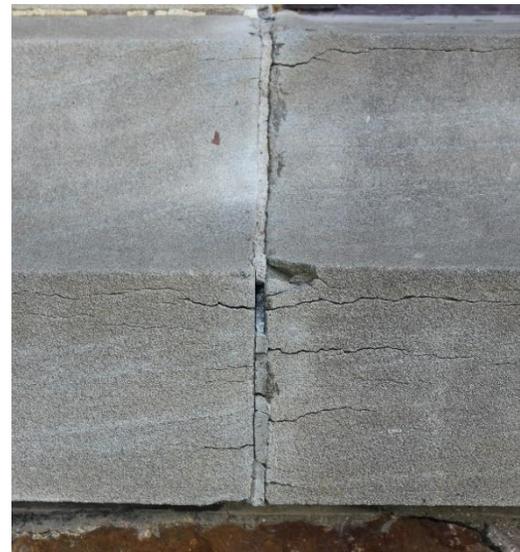
Correcting the mortar joint is relatively easy, however, restoring the faces of these large blocks of limestone is nearly impossible. When stones are cut and finished in a rectilinear pattern, as seen below, it is more cost-effective, and the results more attractive to simply replace the stone. A skilled stone conservator can fill the

hairline cracks seen in the image to the right. For this process, the joint should be prepared for re-pointing, then the hairline cracks should be repaired. The re-pointing can be completed once the stone patch has completely cured.

Of the three masonry units, the limestone is the most fragile. For that reason, I recommend engaging a stone conservator to fill the hairline cracks which exist in the limestone to prevent further deterioration.

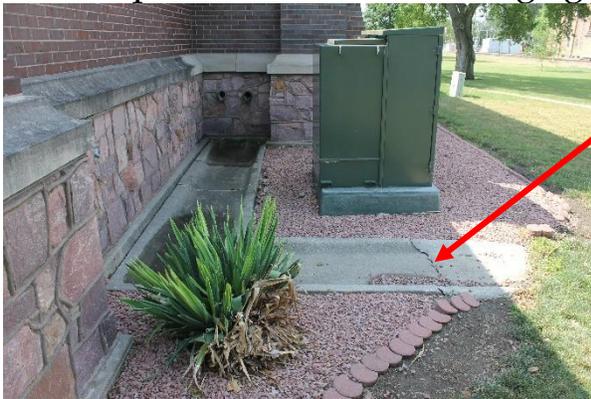
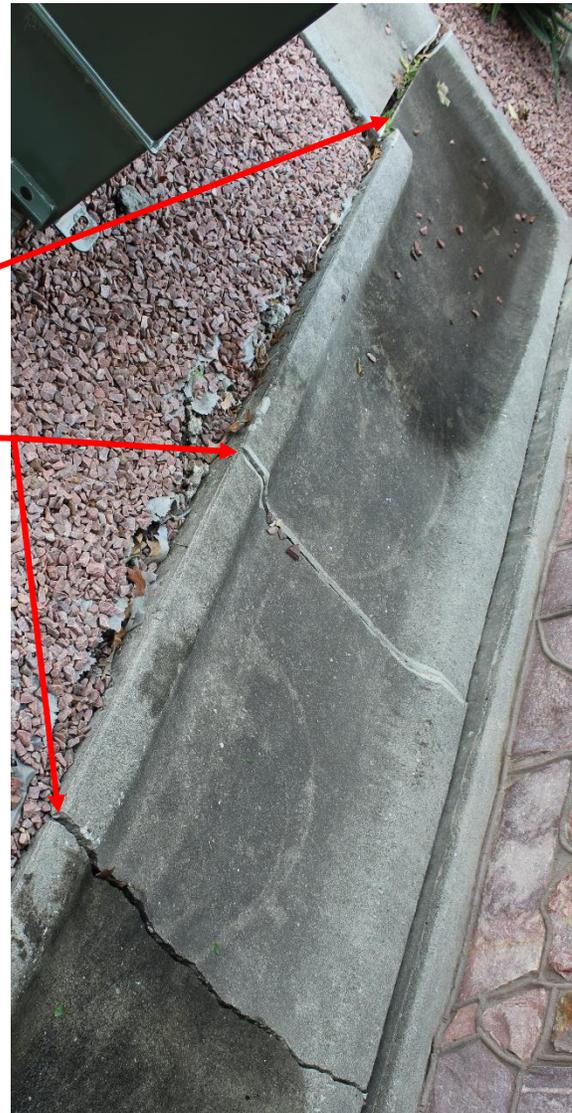
Generally, site drainage is handled appropriately. The exceptions are the custom poured concrete drainage gutters. This on the west side of the

addition is the worst offender. Water is actually standing in the gutter and a crack across the gutter exist near the discharge location.

Upon closer examination, there is an open joint which was hidden by the plant in the earlier image. Another control joint and what appears to be an “unplanned” crack upstream.

Typically, concrete gutters like this one are poured directly on the ground without the benefit of a frost footing. In this case the gutter is located over backfill installed after the footings and foundation for the addition were constructed. Frost heaving is likely the cause for the movement which caused the cracks and separated the joints of this gutter. These opening are permitting water to seep down to the foundation. The addition has only enough space for the elevator equipment room below grade.

Unfortunately, it is located relatively close to this gutter and moisture is getting into that room. It may be in the library’s best interest to collect the roof drainage in a mini storm sewer and discharge it away from the building.

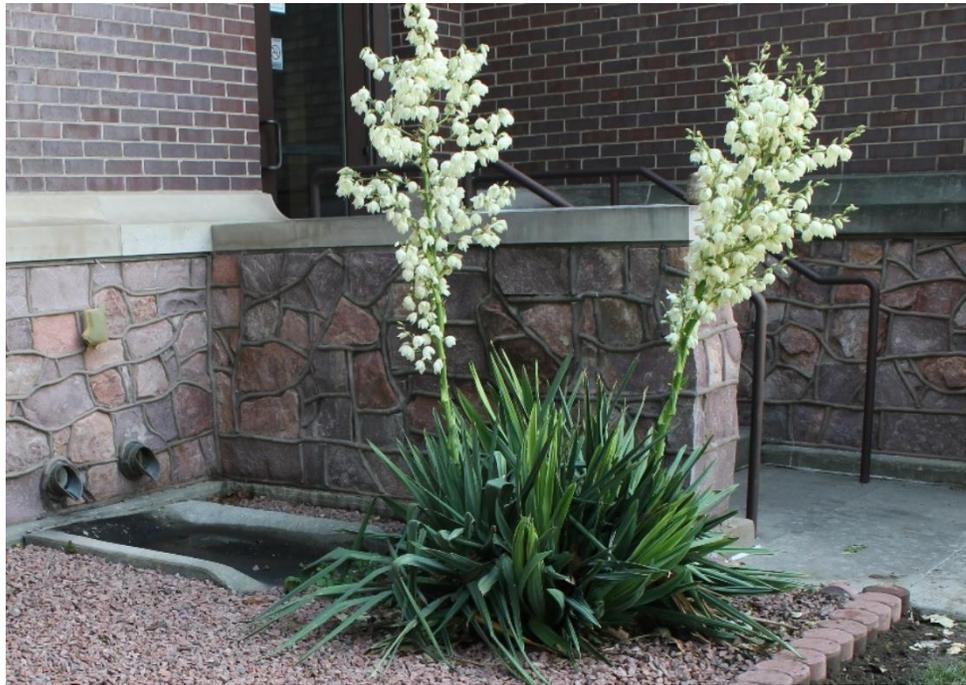
This condition also exists on the west side of the library. Water can be seen standing in the concrete gutter. It also appears that the yucca plant and the concrete edging for the crushed rock is blocking the

flow of rain water away from the building. If a mini storm sewer system is created, the water from this location should be included. A former

There are two sets of lambs tongue drain spouts in this general area. They should have the roof runoff directed into grade level catch basins connected to a mini storm sewer system. The discharge from the mini storm sewer should be more than 20 feet away from the building.

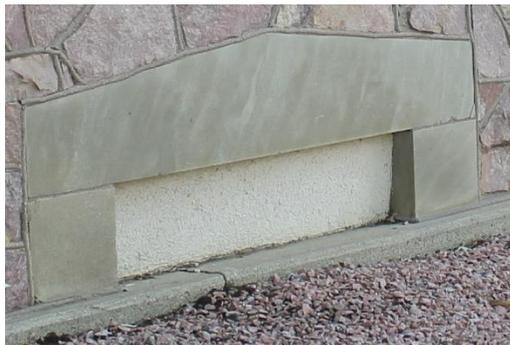
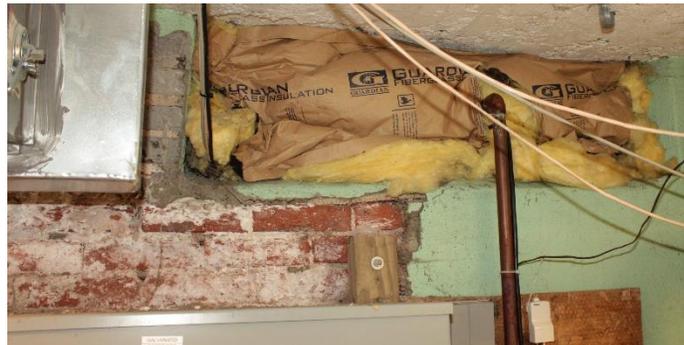
basement window is located just a few feet north of the above gutter. It serves the basement mechanical room, formerly as a window and currently as a utility access point. Dampness can be seen on the window sill. Below is the same window from inside the basement. The window, to the lower left

was properly filled and no moisture was noted at that location.

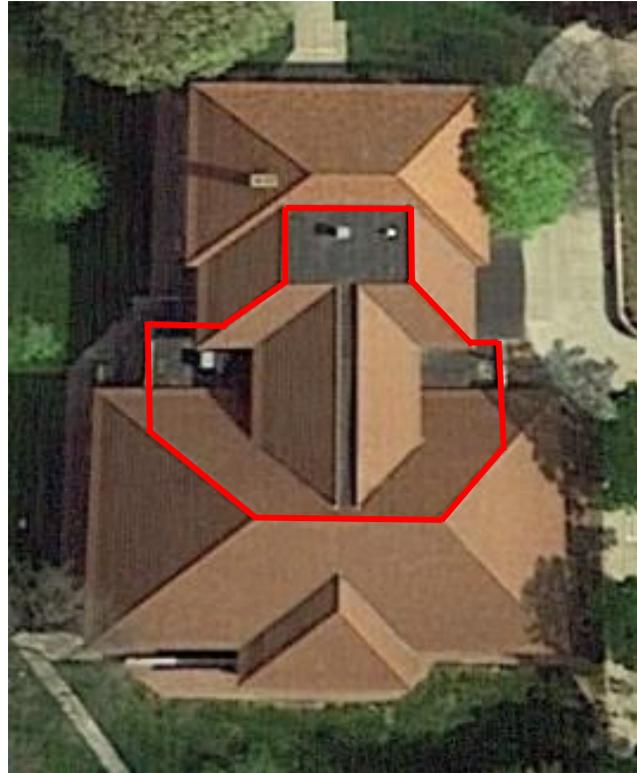
The shingled roof has no gutters or downspouts. The roof drains collect water from the flat roofs and from the shingled portion which spills onto them from above. The red lines indicate roughly the amount of roof drainage that is discharged via the lambs' tongues on the sides of the building. It also illustrates that the majority of the shingled roof spills off the edge and lands in the crushed rock area surrounding the building and its addition. This system is good in that there is never a concern about leaves collecting in and clogging gutters at the roof's edge.

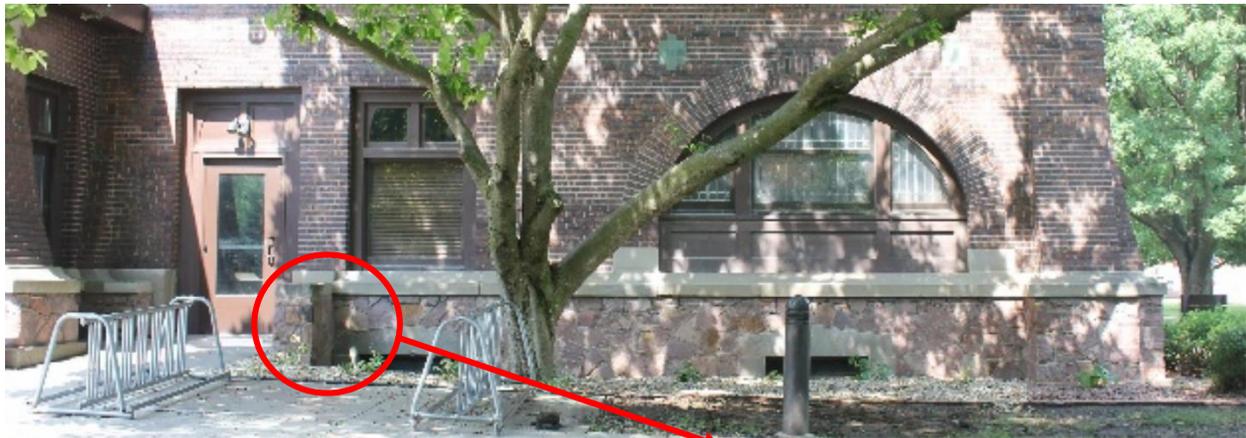
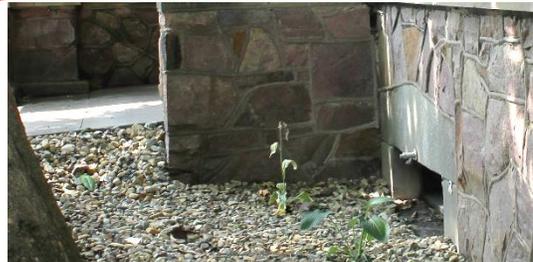
However, as noted on the previous page, the edging for the crushed rock hinders the flow of run off away from the building. On the east side of the building there are additional issues. A retaining wall was added adjacent

to the side door but then the grade north of the wall was not lowered accordingly. Crushed rock at this location is above the basement window sill. Also, the grade seems to slope down to the window from the bicycle parking area. The appearance is more evident in the image on the following page.

Drainage on the east also needs to be collected in catch basins and routed away from the building in a mini storm sewer system. Unlike the west, I do not foresee the need to expose the foundation and apply dampproofing.
