ONAWA PUBLIC LIBRARY
Building Assessment
July 15, 2021

Onawa Public Library Building Assessment

June 24, 2021

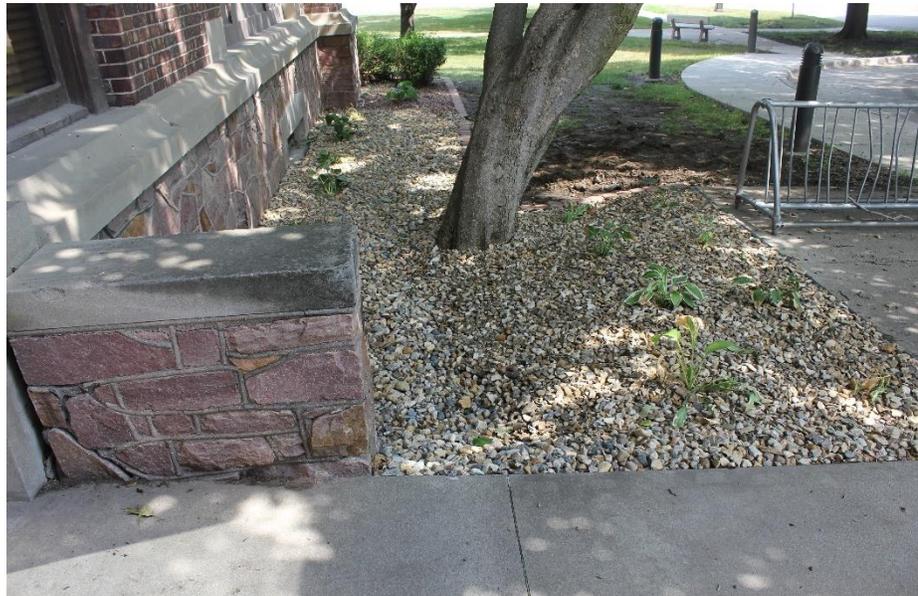
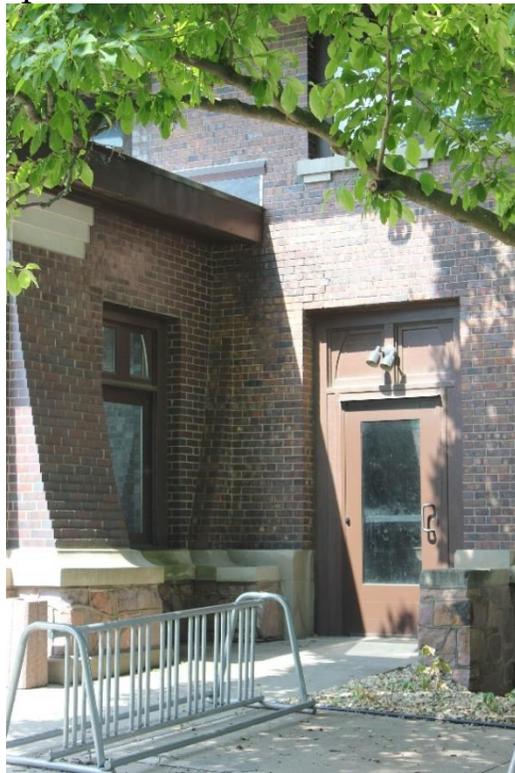
The retaining wall does not appear to be anchored solidly to the original building and/or, it is not on a frost footing. Like the cheek wall in the front, it has moved away from the library. The canopy roof also

spills water into this area as can be seen in the image below left. The area is along the north side of the new entry way and shaded all year long. The quantity of water, its slow rate of drainage and the constant shade has resulted in algae growth on the limestone.

After considering the amount of roof that drains into this area, the best solution is to capture that water and take it under ground either to the north or to the east. There are advantages and disadvantage with either choice. Consulting a civil engineer may lead to your best options. Discussing this problem with others in the office we believe a Japanese inspired chain would look more attractive than a metal gutter system.

Once the roof runoff is contained, cleaning the algae off of the limestone is relatively simple task. Prosoco is one of several manufacturers who have designed products specifically for cleaning masonry and products to remove biological growth on masonry.

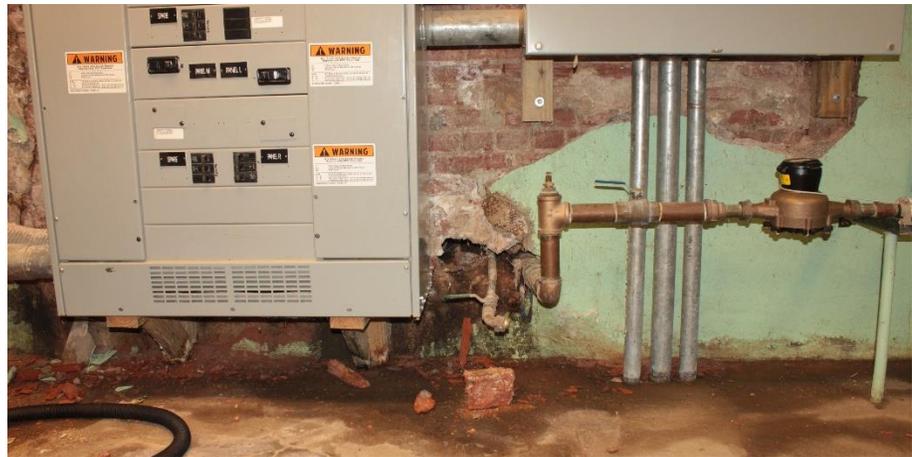
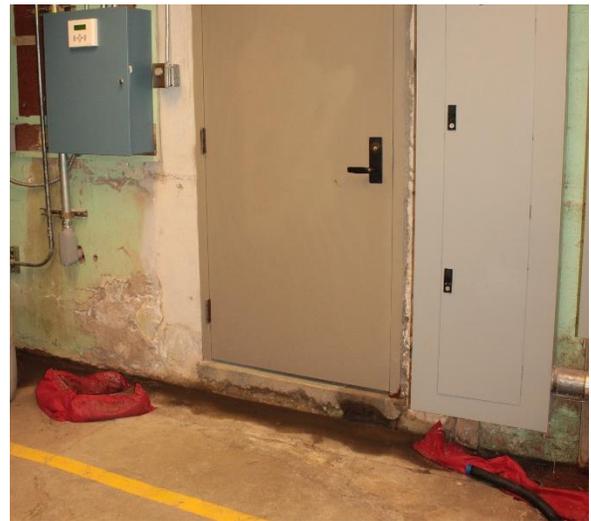
Poor site drainage is a primary reason there is moisture in the basement. The west wall of the basement just to the south of the former window, now utility entrance, has lost most of its plaster due to excessive amounts of moisture. The floor is obviously wet from the previous night's rain. The moisture has moved along the south wall past the door to the elevator equipment room. The equipment room door was cut into the original foundation and the room itself is the only below grade space in the addition.

It is essential to do what it takes to keep the mechanical and elevator equipment rooms dry. While some of the water is entering the mechanical rooms through the open window, leaks other than the via the window must be the source of water in the elevator equipment room. I recommend that the west foundation wall, adjacent to the mechanical and elevator equipment rooms be exposed on the exterior. All masonry joints in the foundation wall should be checked for soundness with all unsound joints cleaned out to a minimum depth of one inch, then repointed with mortar matching the original formula. When the re-pointing mortar has cured, then the wall should have a coating of dampproofing material applied.

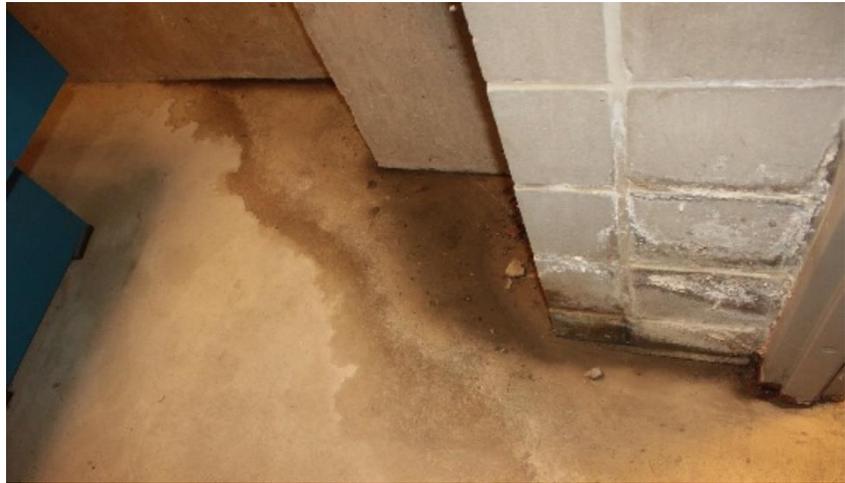
The equipment room is about five inches above the basement floor. However, moisture was present in that room as well. The efflorescence on the concrete block is evidence that moisture has collected in this room many times.

Moisture needs to be eliminated from both of these rooms. The nearly constant presence of moisture promotes rust on the equipment and will shorten its life expectancy. There is a sump pump in the mechanical room which was full when I arrived. It did start and discharged the water out of the building.

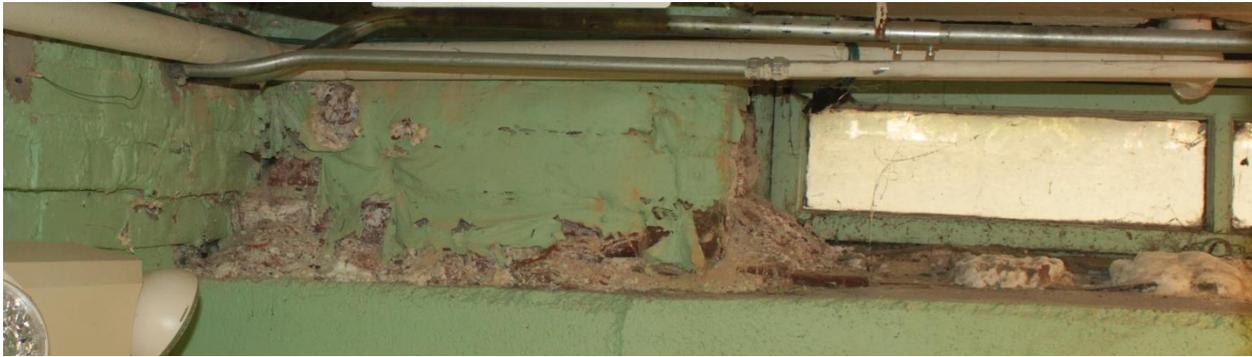
The window above is on the east side of the basement and there is evidence that moisture has gotten into the building at this location.

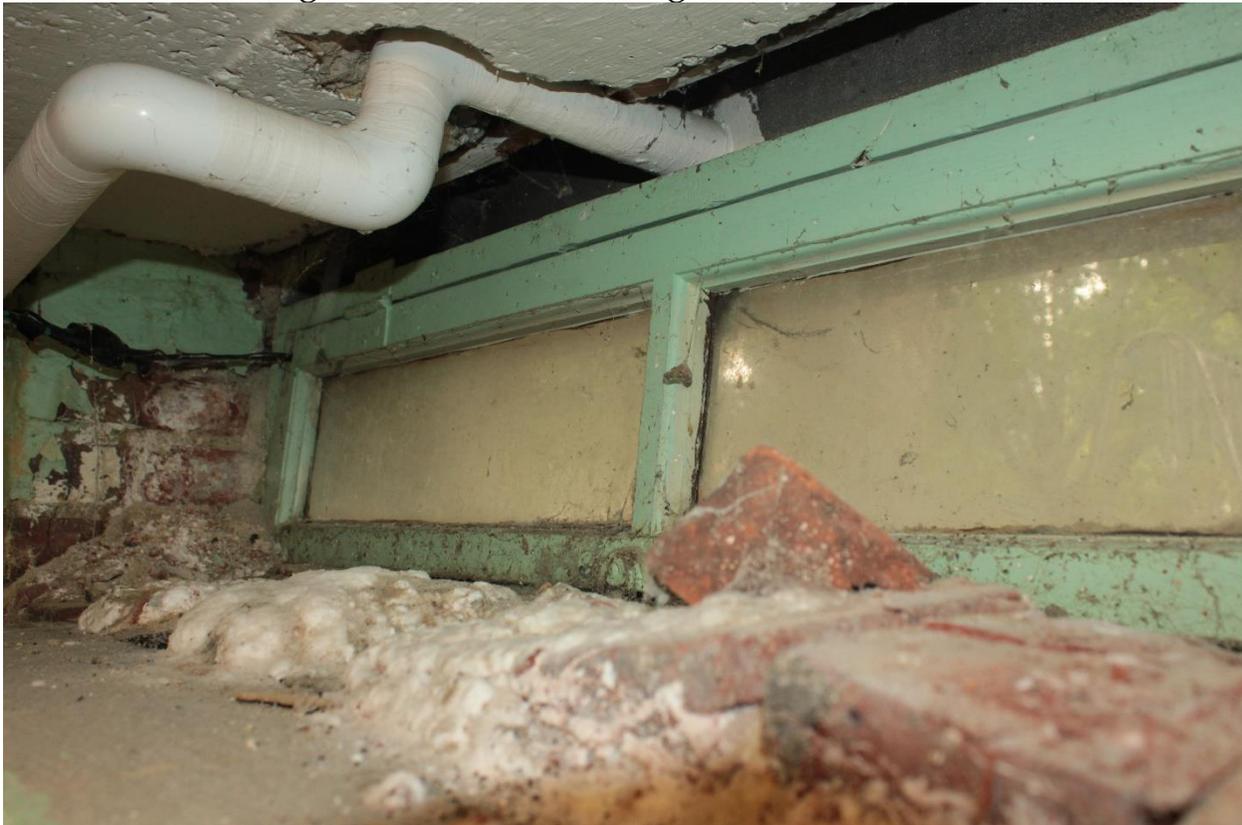
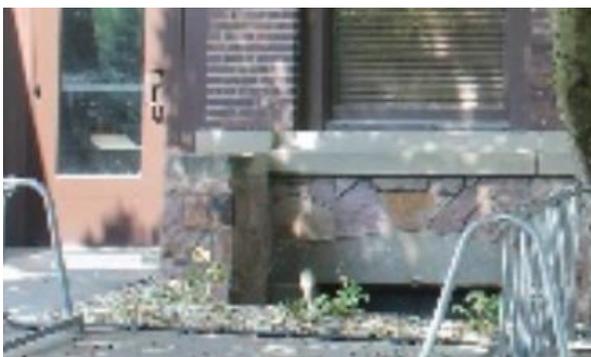
As a point of reference, this is the basement window located just north of the original side entrance. It's also in a location of questionable drainage. Once the drainage outside is repaired, the interior can be cleaned and mortar softened by exposure to excessive moisture can be replaced.

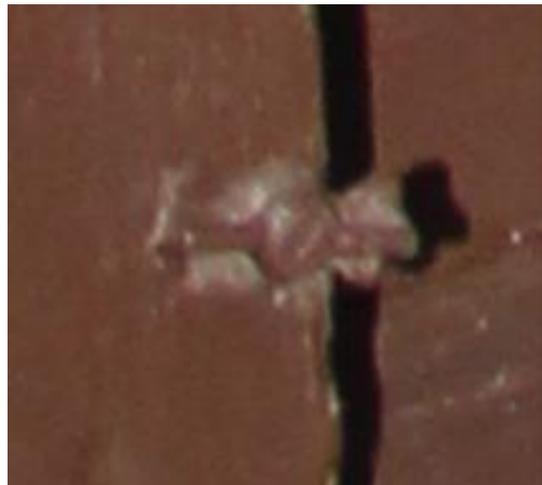
Clear covers have been added to the windows for improved thermal efficiency and to protect the historic leaded glass windows. It appears that caulking was used to seal the covering on its entire perimeter. If that is correct, condensation will occur in the space between the clear cover and the window. If not vented, the condensation will accelerate the deterioration of the wood. Small weep holes need to be provided at the window sill to provide proper venting. In the future you may want to consider more traditional storm windows. They would be more convenient for cleaning the glass surface and when it is time to repaint the original wood windows. A turn button which is typically used to hold storm windows in place still exists on the original south elevation window. Re-introducing traditional storm windows would be an act of restoration.

Eventually restoring the original storm windows is my recommendation. However, many historic structures have clear coverings over the historic windows and are surviving just fine. Historic storm windows would be the lowest priority of all recommendations I have offered.

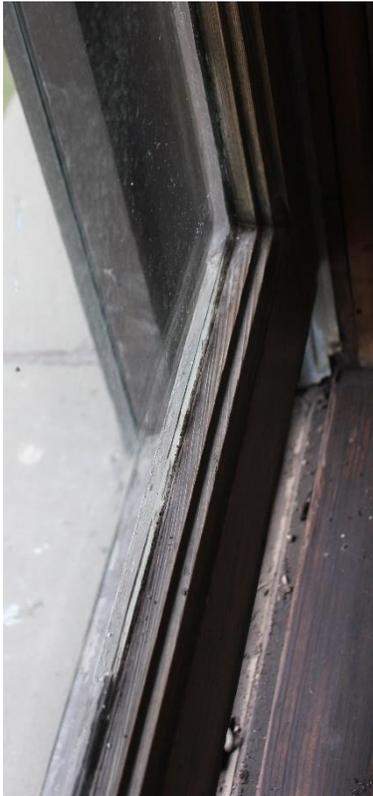
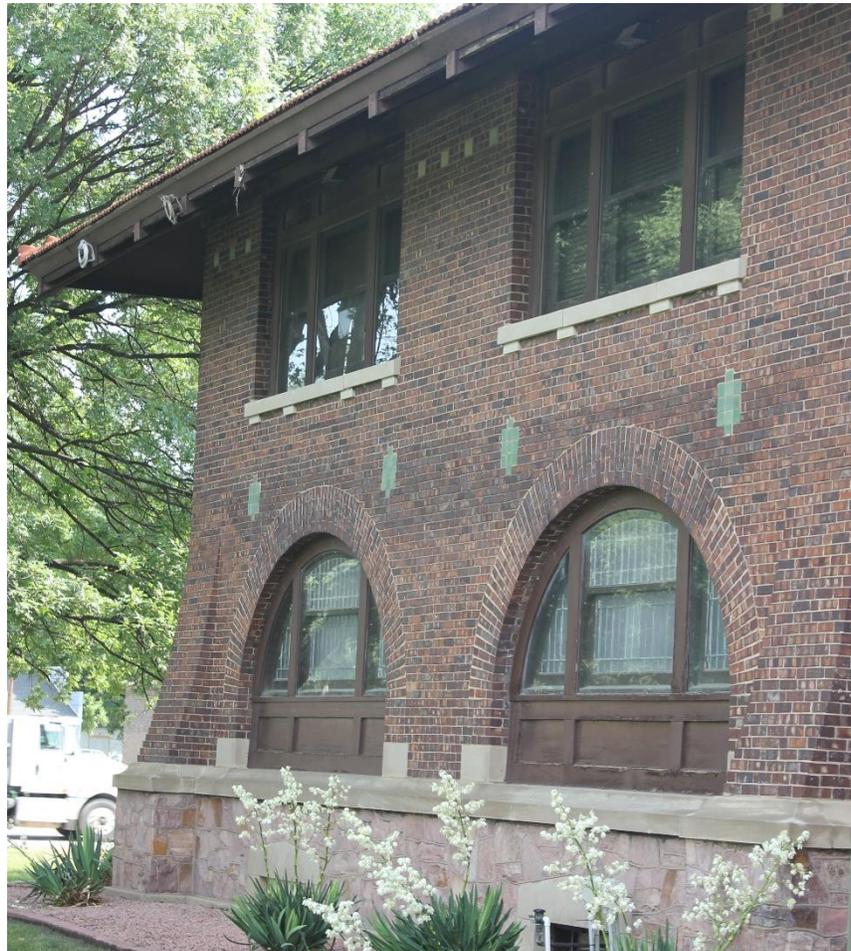
To the left you can see that glazing putty in many locations had dried

out and fallen away. These areas should be thoroughly cleaned, removing all loose putty. The raw wood of the sash will need a generous application of boiled linseed oil to help the new glazing putty adhere to the wood. The putty should be painted as soon as it achieves its initial set.
