ONAWA PUBLIC LIBRARY
Building Assessment
July 15, 2021

Onawa Public Library Building Assessment

June 24, 2021

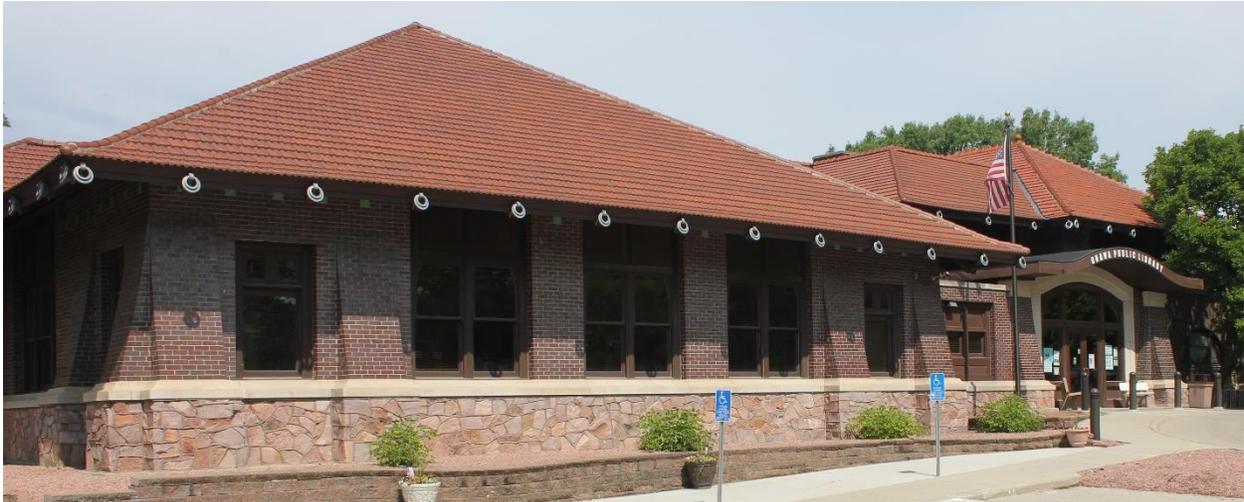
These misalignments are minor as compared to those on the north and east.

As expected, the shingles on the addition are in excellent shape.

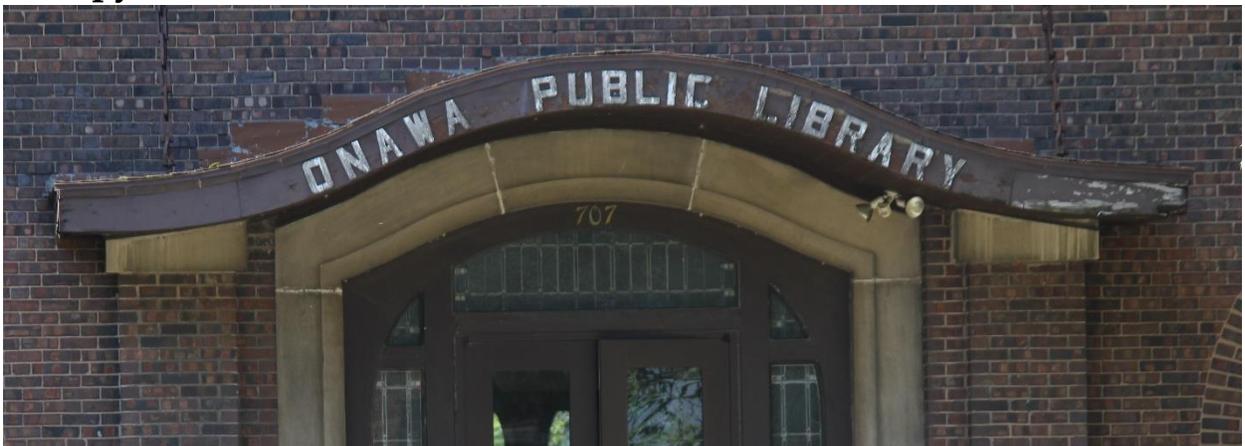
There is obvious deterioration at the eaves and on the fascia boards. There are water stains on the limestone pilaster caps beneath the canopy and the wood trim pieces at the pilasters are loose.

This damage is due to roof leaks, if not current, then at some time in the past. The image, of the canopy, to the right is from the 2nd floor window. Drainage from the roof is so slow that moss has begun to grow on the asphalt shingles. The moss further impedes the drainage process.

In addition, it is imperative to re-roof the canopy at the historic front entrance. During the process, the flashing should be redesigned to extend up the wall not less than 8 inches. The counter flashing should be redesigned to extend horizontally over the top of the lower course of counter flashing by not less than 4 inches. I highly recommend that the roof, flashing, counter flashing and trim all be copper. Copper has a life expectancy approaching 100 years or longer.

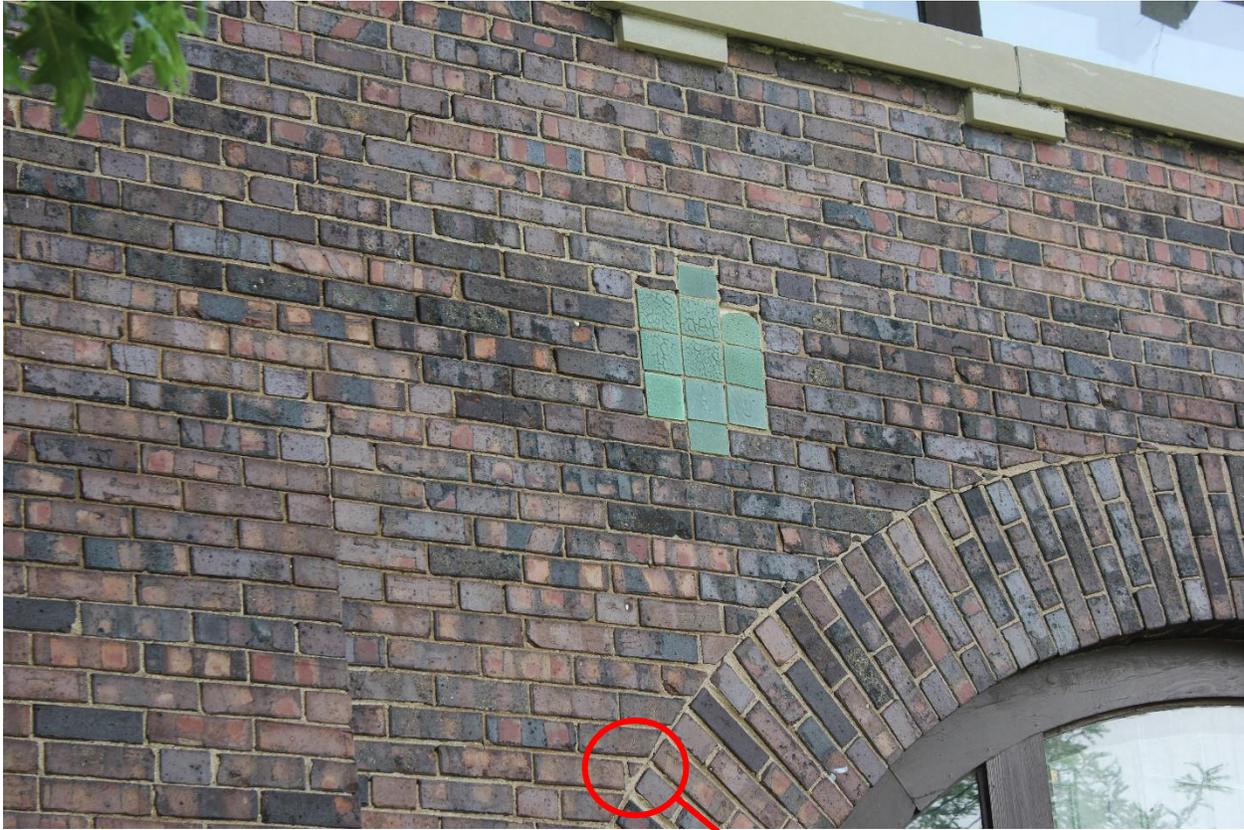
The masonry used to construct the library is of very high quality. The installation seems to be of equally high quality with few exceptions. The image below is of the west elevation and shows nearly flawless joints.

Before any masonry repairs are made, mortar analysis needs to be performed. It will identify the percentage of aggregate, percentage of binder and the type of lime used to make up the binder. If any Portland cement is present, that will also be identified including the ratio of Portland to lime. I believe there is some Portland in the original mortar mix due to the presence of hairline cracks, commonly occurring between the mortar and the masonry units. These hairline cracks have not progressed enough to require re-pointing of the joint.

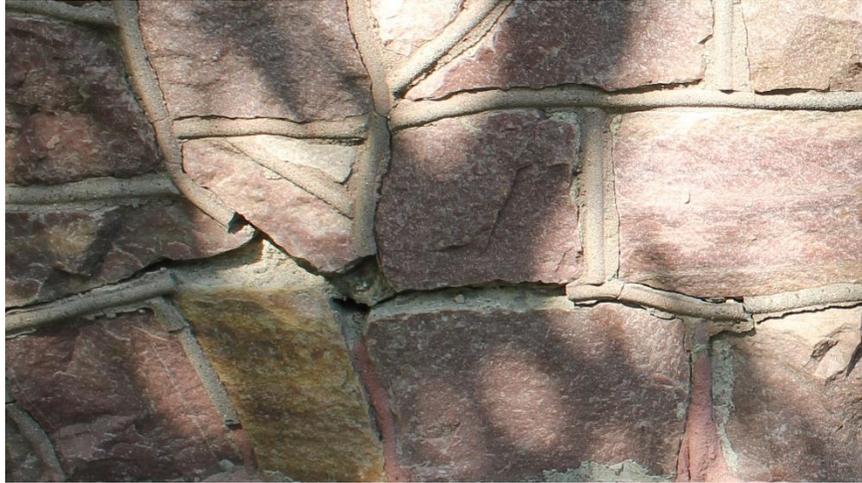
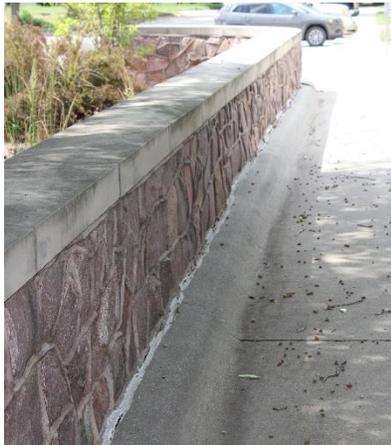
A more challenging issue exists at the granite retaining wall just east of the drop-off driveway. There is insufficient space between the poured concrete and the stone wall. The concrete is not on a frost footing thus, throughout the winter, the concrete is forced up and down from the freezing

and thawing of the soil beneath. Most frequently it is breaking the extruded mortar off the wall. Occasionally, the stone or the concrete is fractured. The wall and the driveway should be separated by

There are numerous locations which would benefit by re-pointing in the near future. However, there is really only one issue for which I recommend immediate action: the concrete driveway adjacent to the retaining wall at the new entrance, by freeze/thaw action, damaging the wall, its mortar and the concrete drive itself. As soon as your roof repairs are complete, funds should be raised to make this correction.

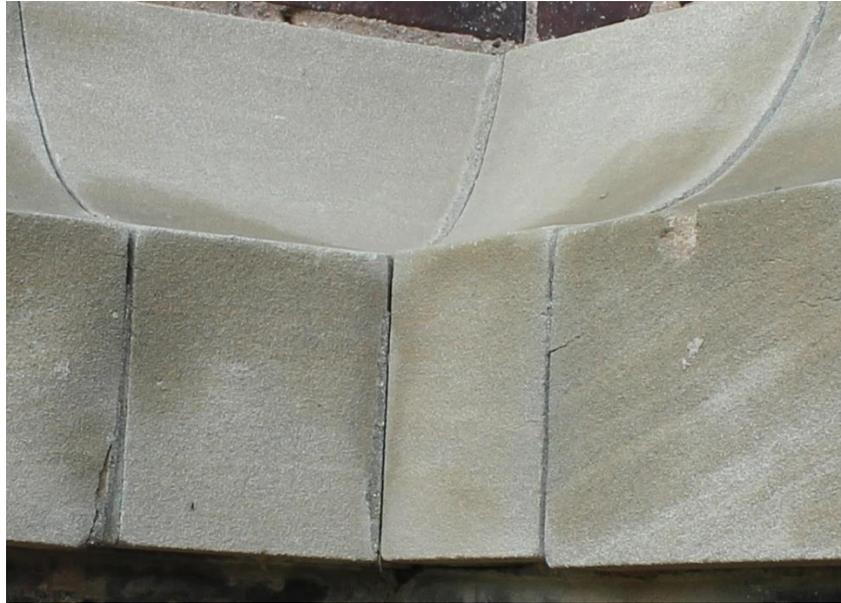
The limestone trim was very accurately fabricated lending itself to very narrow mortar joints. Only a very experienced craftsman would be qualified to repoint these joints.

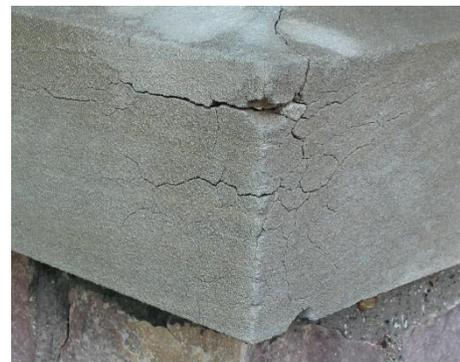
Of the three masonry units, the limestone is the most fragile. For that reason, I recommend engaging a stone conservator to fill the hairline cracks which exist in the limestone to prevent further deterioration.

The same conservator will have the skill to repoint the very narrow joints of the limestone trim. During this project, the spalled limestone trim should be replaced and any necessary Dutchman patches should be installed.

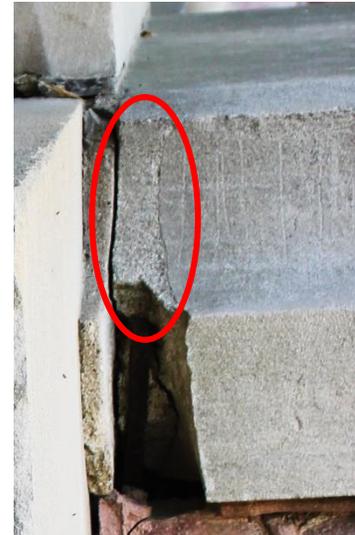
Once the limestone has been preserved, the remainder of the re-pointing can be scheduled. The cheek walls at the original front entrance deserve a bit more investigation. As noted, they have moved. I believe they have stopped moving. That can be verified by installing a simple “crack monitor.” If they have not stopped moving then the repairs will require disassembly and construction of frost footing for each wall. On the other hand if, as I believe, they have stopped moving, they can be re-pointed in situ. Or, cost analysis could be done to estimate the expense of disassembly so that they could be reconstructed in their original location. To the right, the red circle illustrates the amount of mortar that was added to this joint to fill the void created by the capstone’s movement.

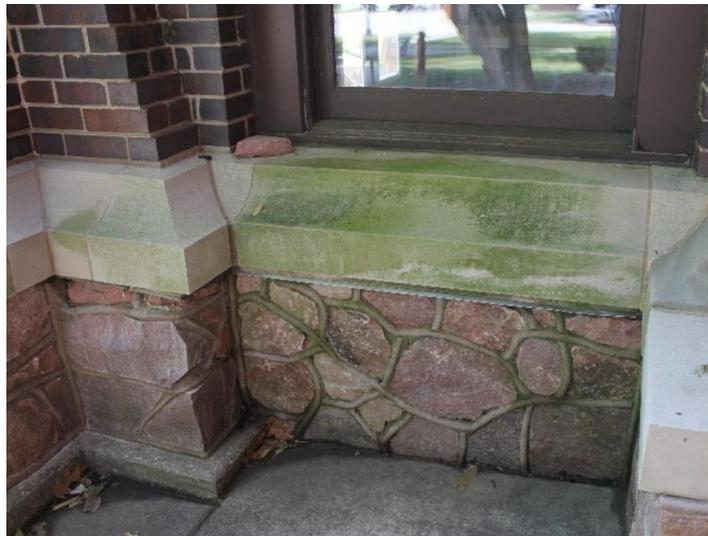
spills water into this area as can be seen in the image below left. The area is along the north side of the new entry way and shaded all year long. The quantity of water, its slow rate of drainage and the constant shade has resulted in algae growth on the limestone.

After considering the amount of roof that drains into this area, the best solution is to capture that water and take it under ground either to the north or to the east. There are advantages and disadvantage with either choice. Consulting a civil engineer may lead to your best options. Discussing this problem with others in the office we believe a Japanese inspired chain would look more attractive than a metal gutter system.

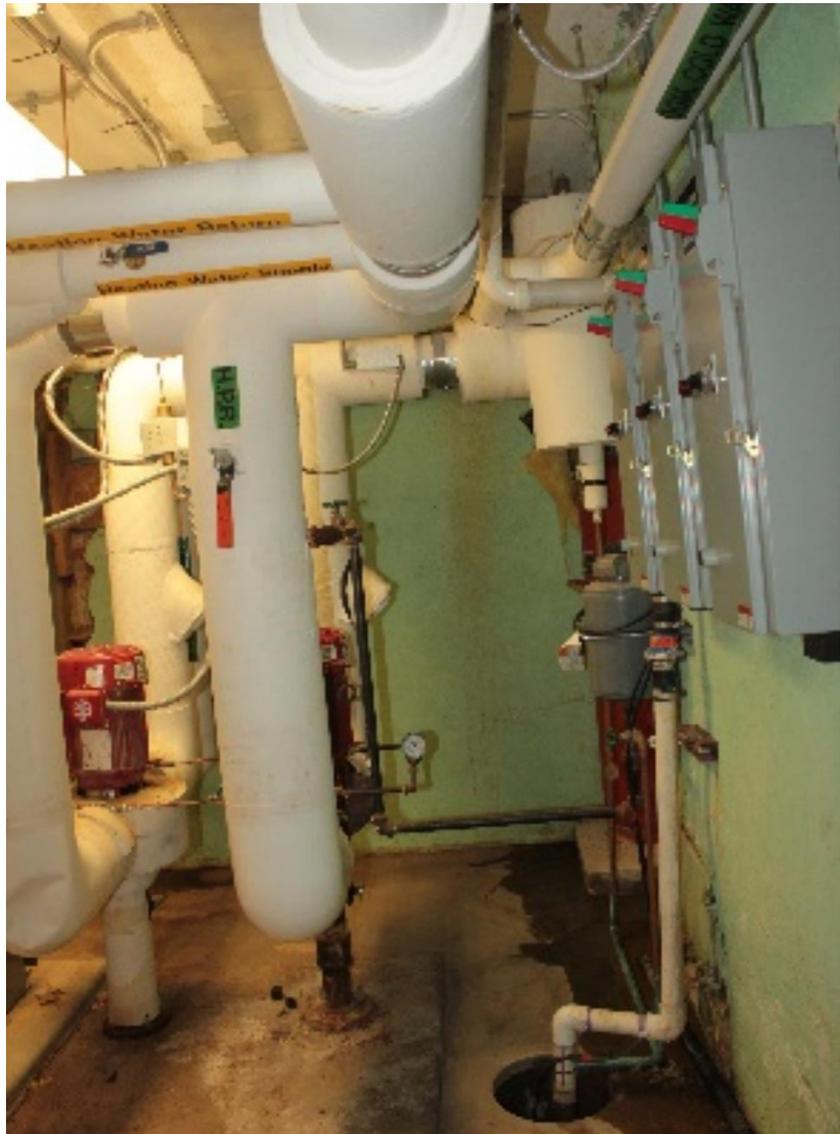
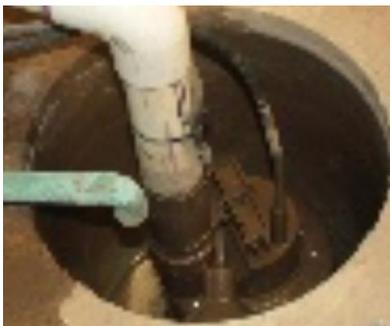
Moisture needs to be eliminated from both of these rooms. The nearly constant presence of moisture promotes rust on the equipment and will shorten its life expectancy. There is a sump pump in the mechanical room which was full when I arrived. It did start and discharged the water out of the building.

The window above is on the east side of the basement and there is evidence that moisture has gotten into the building at this location.

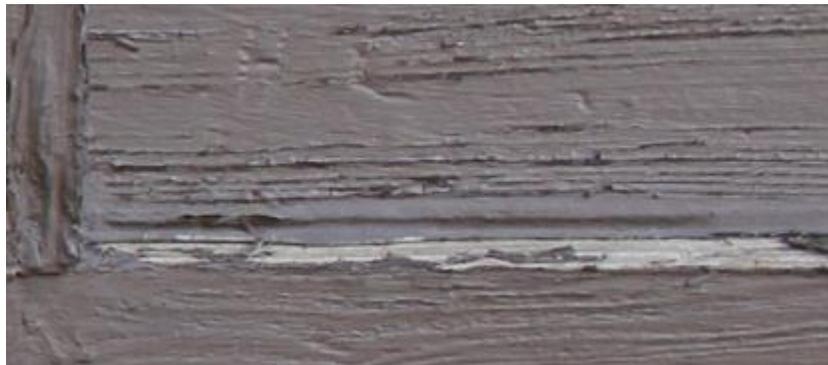
In the example to the right, you can see that most of the paint is still bonded to the surface really well. There is probably five to seven years of life left in most of the painted surfaces.

However, places where it has peeled away and exposed raw wood need attention soon. These small areas should be sanded down to bright wood. Then primed, with a good linseed oil base primer. The finish paint probably won't match because of the sun fading the surface. With that in mind it will be less noticeable if the touch up areas are kept small, or if you paint an entire surface to a corner.

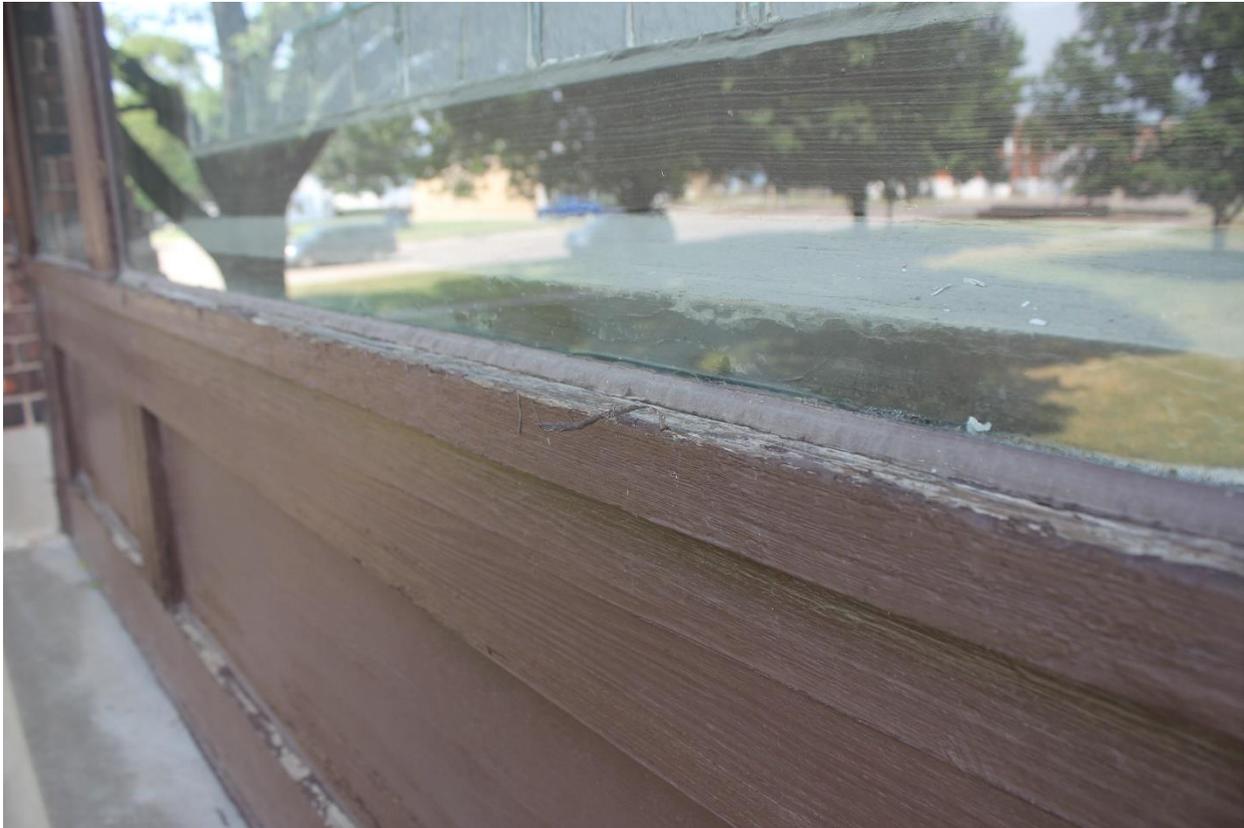
Clear covers have been added to the windows for improved thermal efficiency and to protect the historic leaded glass windows. It appears that caulking was used to seal the covering on its entire perimeter. If that is correct, condensation will occur in the space between the clear cover and the window. If not vented, the condensation will accelerate the deterioration of the wood. Small weep holes need to be provided at the window sill to provide proper venting. In the future you may want to consider more traditional storm windows. They would be more convenient for cleaning the glass surface and when it is time to repaint the original wood windows. A turn button which is typically used to hold storm windows in place still exists on the original south elevation window. Re-introducing traditional storm windows would be an act of restoration.
